Appendix B: Tabular Inventory of Surveyed Properties

H Historical Studies Report, Texas Department of Transportation, Environmental Affairs Division

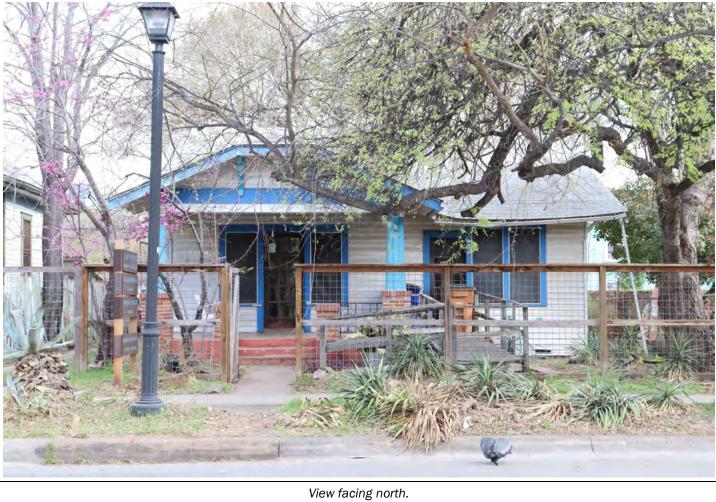
Integrity Considerations:	Alterations include replacement siding and porch alterations to add a access ramp. Due to alterations, Resource 1003 has lost integrity of materials. Resource 1003 retains integrity of location, design, workmanship, feeling, setting, and association.

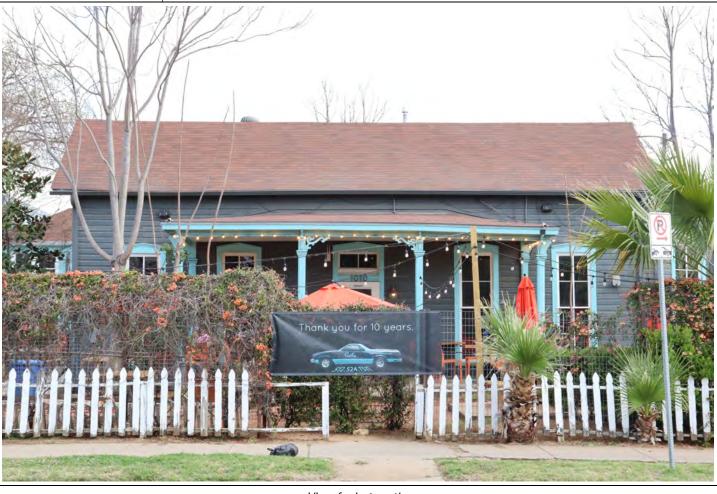
View facing north.

Survey Date:	March 28, 2022
Resource No.	1004A
Project Location:	Austin, Travis County, Texas. I-35 from US 290 E to US 290 W/SH 71
Project Name and CSJ:	I-35 Capital Express Central Reconnaissance Survey - East Cesar Chavez Street Addendum, 0015-13-388
Address, Lat/Long:	1010 East Cesar Chavez Street, 30.260527/-97.733673
Function/Sub-function:	DOMESTIC/Single Dwelling (now COMMERCE/TRADE/Business)
Construction Date:	c.1885
Architectural Style/Form:	Folk Victorian
NRHP Eligibility:	Individually eligible (Criterion C: Architecture); contributing to the recommended NRHP-eligible East 1st Street Historic District (Criteria A and C).
Description/Comments:	One-story, irregular-plan, side-gable, Folk Victorian residence converted for use as a restaurant. Pier and beam foundation. Asphalt-shingle roof. Horizontal wood siding. Centered, partial-width, hip-roof porch with jig-sawn braces. 4/4 wood sash windows with some 9/9 vinyl replacement sashes on rear elevation. Historic-age board and batten addition on rear elevation. Resource 1004A is contributing to the recommended NRHP-eligible East 1st Street Historic District. It is individually significant under Criterion C in the area of Architecture. It does not possess historical significance within the historic contexts necessary for individual eligibility under Criteria A or B. See HRSR text for detailed NRHP evaluation.

Integrity Considerations:	Alterations include some replacement windows and doors. Despite minor alterations, Resource 1004A retains all aspects of integrity.
N B WWWW	MALLY IN I IN THE REAL AND A MARKED AND AND AND AND A MARKED AND AND AND AND AND AND AND AND AND AN

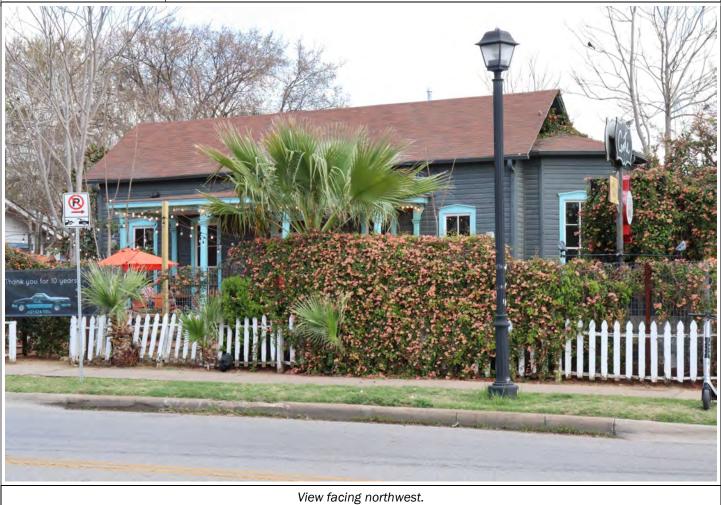
Integrity Considerations:	Alterations include some replacement windows and doors. Despite minor alterations, Resource 1004A retains all aspects of integrity.

Survey Date:	March 28, 2022
Resource No.	1004A
Project Location:	Austin, Travis County, Texas. I-35 from US 290 E to US 290 W/SH 71
Project Name and CSJ:	I-35 Capital Express Central Reconnaissance Survey - East Cesar Chavez Street Addendum, 0015-13-388
Address, Lat/Long:	1010 East Cesar Chavez Street, 30.260527/-97.733673
Function/Sub-function:	DOMESTIC/Single Dwelling (now COMMERCE/TRADE/Business)
Construction Date:	c.1885
Architectural Style/Form:	Folk Victorian
NRHP Eligibility:	Individually eligible (Criterion C: Architecture); contributing to the recommended NRHP-eligible East 1st Street Historic District (Criteria A and C).
Description/Comments:	One-story, irregular-plan, side-gable, Folk Victorian residence converted for use as a restaurant. Pier and beam foundation. Asphalt-shingle roof. Horizontal wood siding. Centered, partial-width, hip-roof porch with jig-sawn braces. 4/4 wood sash windows with some 9/9 vinyl replacement sashes on rear elevation. Historic-age board and batten addition on rear elevation. Resource 1004A is contributing to the recommended NRHP-eligible East 1st Street Historic District. It is individually significant under Criterion C in the area of Architecture. It does not possess historical significance within the historic contexts necessary for individual eligibility under Criteria A or B. See HRSR text for detailed NRHP evaluation.

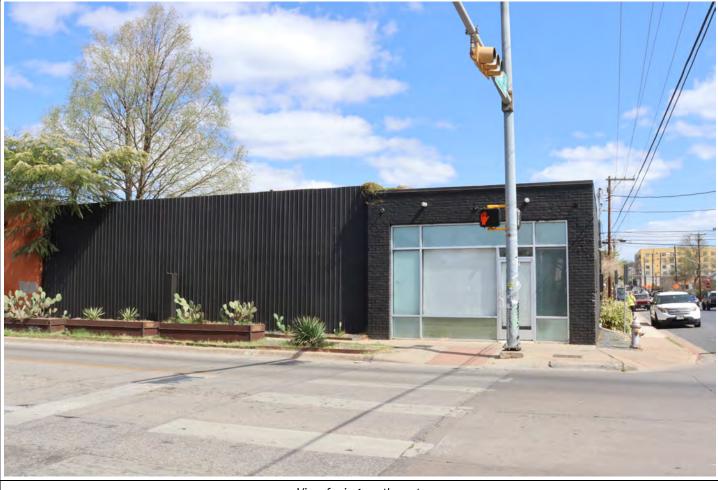
View facing northwest.

Alterations include replacement doors and storefront and a non-historic-age addition. Due to alterations, Resource 1009 has lost integrity of feeling, materials, workmanship, and design. Due to surrounding non-historic-age development, it has diminished integrity of setting. Resource 1009 retains integrity of location and association.
_

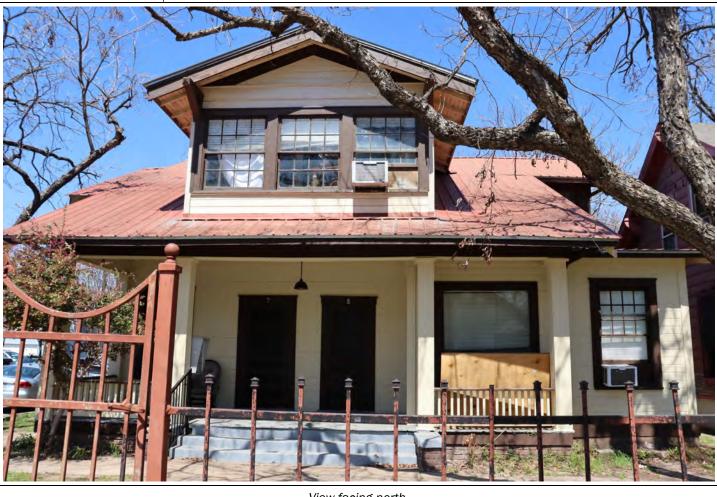
Survey Date:	March 28, 2022
Resource No.	1020
Project Location:	Austin, Travis County, Texas. I-35 from US 290 E to US 290 W/SH 71
Project Name and CSJ:	I-35 Capital Express Central Reconnaissance Survey - East Cesar Chavez Street Addendum, 0015-13-388
Address, Lat/Long:	1300 East Cesar Chavez Street, 30.259682/-97.731362
Function/Sub-function:	DOMESTIC/Multiple Dwelling
Construction Date:	1910
Architectural Style/Form:	Bungalow
NRHP Eligibility:	Not individually eligible but remains a historic property as a contributing resource to the recommended NRHP-eligible East 1st Street Historic District (Criteria A and C).
Description/Comments:	One-and-one-half-story, rectangular-plan, side-gable, bungalow duplex converted to apartments. Pier and beam foundation. Horizontal wood and asbestos siding. Metal roof. Large gabled dormers on front facade and rear elevation, full-width inset porch. Wood windows throughout, mostly 6/6 sashes, but 1/1 sash, casement, awning, and fixed windows also present. Building appears to have been constructed as a duplex but later subdivided into 7 or 8 apartments units. A historic-age, one-story, rear addition and exterior stairs were added for this purpose. Resource 1020 is contributing to the recommended NRHP-eligible East 1st Street Historic District. However, it does not possess historical or architectural significance within the historic contexts necessary for individual listing in the NRHP under Criteria A, B, or C.

Integrity Considerations:	Alterations include altered fenestration and replacement doors and windows. Due to alterations, Resource 1020 has lost integrity of design and feeling. Resource 1020 retains integrity of location, setting, materials, workmanship, and association.

View facing north.

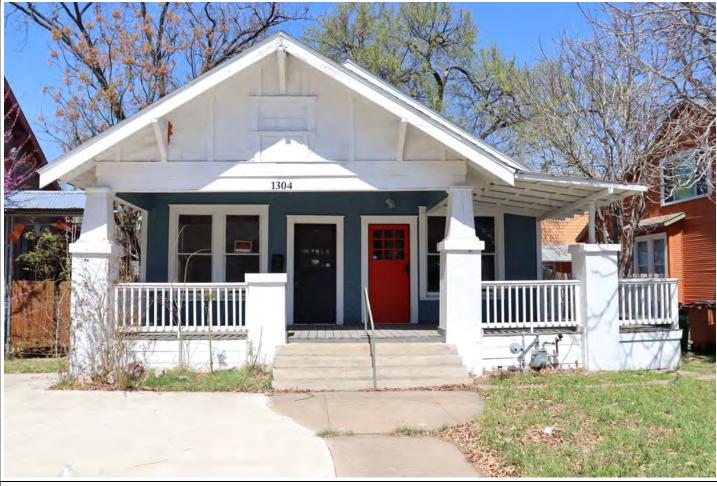
Survey Date:	March 28, 2022
Resource No.	1022
Project Location:	Austin, Travis County, Texas. I-35 from US 290 E to US 290 W/SH 71
Project Name and CSJ:	I-35 Capital Express Central Reconnaissance Survey - East Cesar Chavez Street Addendum, 0015-13-388
Address, Lat/Long:	1304 East Cesar Chavez Street, 30.259551/-97.731117
Function/Sub-function:	DOMESTIC/Multiple Dwelling
Construction Date:	1920
Architectural Style/Form:	Craftsman
NRHP Eligibility:	Individually eligible (Criterion B: Significant Person; Criterion C: Architecture); contributing to the recommended NRHP-eligible East 1st Historic District (Criteria A and C).
Description/Comments:	One-story, rectangular-plan, front-gable, Craftsman-style duplex. Pier and beam foundation. Horizontal wood siding, plywood in gables. Asphalt-shingle roof. Partial-width, gable-roof porch has been converted to a wraparound style with non-historic-age additions. 1/1 wood sash windows. Resource 1022 is contributing to the recommended NRHP-eligible East 1st Street Historic District. Resource 1022 is individually significant under Criterion B for association with Walter E. Davis, a significant person in local history, and Criterion C in the area of Architecture. It does not possess historical significance within the historic contexts necessary for individual eligibility under Criterion A. See HRSR text for detailed NRHP evaluation.

Integrity Considerations:	Alterations are limited to the porch expansion. Despite minor alterations, Resource 1022 retains all aspects of integrity.

View facing north.

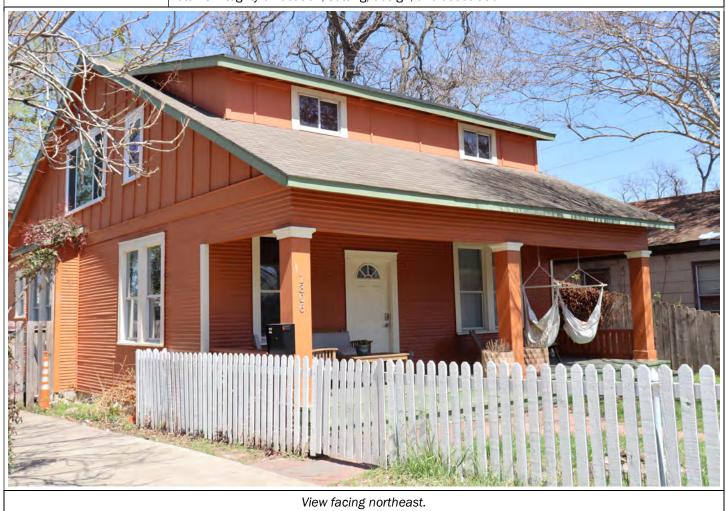
Survey Date:	March 28, 2022
Resource No.	1024
Project Location:	Austin, Travis County, Texas. I-35 from US 290 E to US 290 W/SH 71
Project Name and CSJ:	I-35 Capital Express Central Reconnaissance Survey - East Cesar Chavez Street Addendum, 0015-13-388
Address, Lat/Long:	1308 East Cesar Chavez Street, 30.259461/-97.730824
Function/Sub-function:	DOMESTIC/Single Dwelling (now Multiple Dwelling)
Construction Date:	1915
Architectural Style/Form:	No style
NRHP Eligibility:	Not individually eligible but remains a historic property as a contributing resource to the recommended NRHP-eligible East 1st Street Historic District (Criteria A and C).
Description/Comments:	One-story, L-plan, cross-gable residence. Pier and beam foundation. Asbestos siding. Asphalt- shingle roof. Partial-width, shed-roof porch with simple wood post supports. 2/2 metal sash windows. Large, two-story, side-gable, non-historic-age addition with curved parapets on rear elevation. Addition is covered with metallic insulation but has no cladding; vinyl sash windows. Resource 1024 is contributing to the recommended NRHP-eligible East 1st Street Historic District. However, it does not possess historical or architectural significance within the historic contexts necessary for individual listing in the NRHP under Criteria A, B, or C.

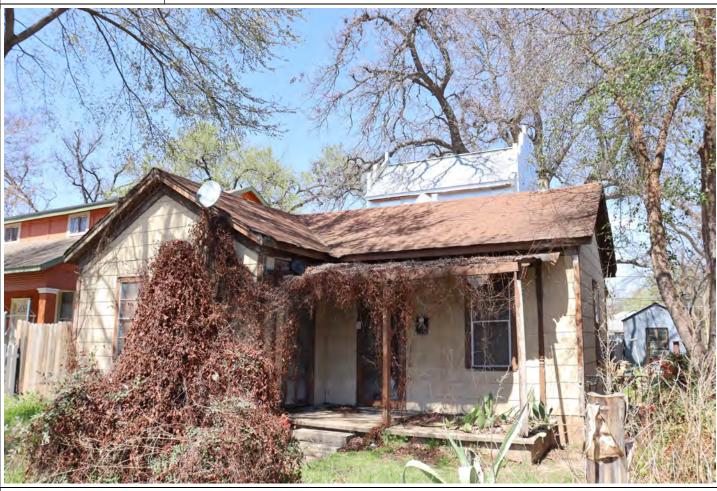
Integrity Considerations:	Alterations include replacement widows and a large, non-historic-age addition. Due to alterations, Resource 1024 has lost integrity of design and feeling, but retains integrity of location, setting, materials, workmanship, and association.

View facing northwest.

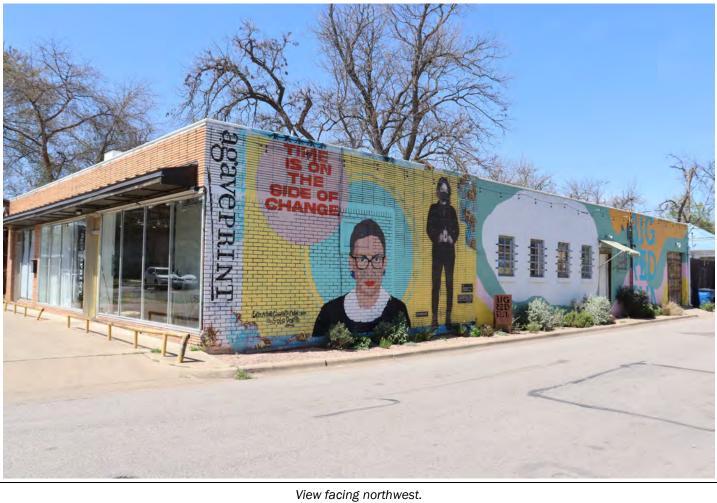
Survey Date:	March 28, 2022
Resource No.	1025
Project Location:	Austin, Travis County, Texas. I-35 from US 290 E to US 290 W/SH 71
Project Name and CSJ:	I-35 Capital Express Central Reconnaissance Survey - East Cesar Chavez Street Addendum, 0015-13-388
Address, Lat/Long:	1312 East Cesar Chavez Street, 30.259456/-97.730650
Function/Sub-function:	COMMERCE/TRADE/Business (now Professional)
Construction Date:	1950
Architectural Style/Form:	No style
NRHP Eligibility:	Not individually eligible but remains a historic property as a contributing resource to the recommended NRHP-eligible East 1st Street Historic District (Criteria A and C).
Description/Comments:	One-story, rectangular-plan, flat-roof commercial building. Concrete slab foundation. Stacked brick and concrete-block masonry walls. Two storefronts on front facade with fixed, metal frame windows and doors. Metal awning extends across facade. Metal casements on side elevations. Former storefront windows on south side of east elevation now infilled with brick. Row of metal windows, single entry door, and garage bay with historic-age overhead sliding garage door on north side of east elevation. Resource 1025 is contributing to the recommended NRHP-eligible East 1st Street Historic District. However, it does not possess historical or architectural significance within the historic contexts necessary for individual listing in the NRHP under Criteria A, B, or C.

Integrity Considerations:	Alterations include replacement doors and altered fenestration. Due to alterations, Resource 1025 has lost integrity of design, but retains integrity of location, materials, workmanship, feeling, setting, and association.
	ALL MARKEN WE NOT A COMPANY AND A COMPANY

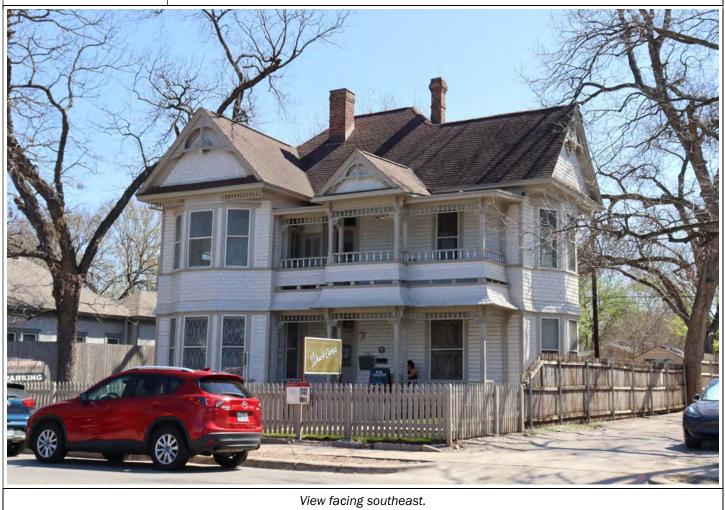
Survey Date:	March 28, 2022
Resource No.	1026
Project Location:	Austin, Travis County, Texas. I-35 from US 290 E to US 290 W/SH 71
Project Name and CSJ:	I-35 Capital Express Central Reconnaissance Survey - East Cesar Chavez Street Addendum, 0015-13-388
Address, Lat/Long:	1301 East Cesar Chavez Street, 30.259347/-97.731558
Function/Sub-function:	DOMESTIC/Single Dwelling (now COMMERCE/TRADE/Business)
Construction Date:	1898
Architectural Style/Form:	Queen Anne
NRHP Eligibility:	Individually listed (Criterion A: Commerce and Criterion C: Architecture); contributing to the recommended NRHP-eligible East 1st Historic District (Criteria A and C).
Description/Comments:	Two-story, L-plan, Queen Anne residence converted to commercial use. Hip roof with lower cross gables. Pier and beam foundation. Asphalt-shingle roof. Horizontal wood cladding with wood shingles in horizontal band at second floor and in gables. Two-story inset porch with front-gable extension. Wood sash windows. Rear addition. Architect J.J. Byrdson. Non-historic-age shed in rear. Resource 1026 is an Austin Historic Landmark. Resource 1026 is contributing to the recommended NRHP-eligible East 1st Street Historic District. It is individually listed in the NRHP under Criterion A in the area of Commerce and and Criterion C in the area of Architecture.

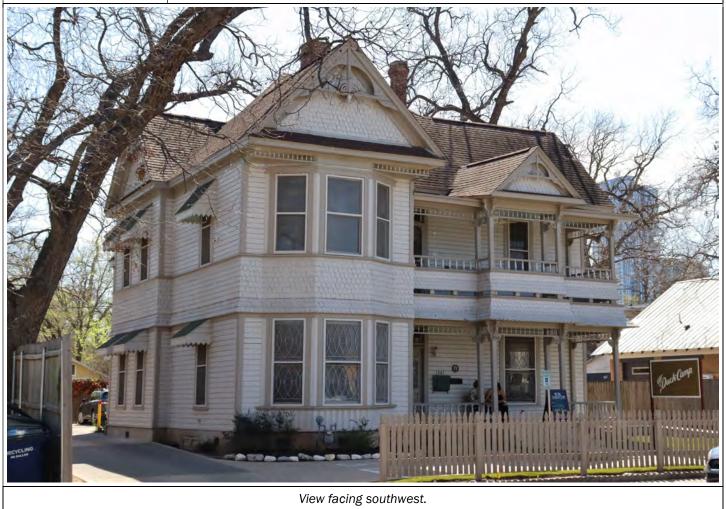
Survey Date:	March 28, 2022
Resource No.	1026
Project Location:	Austin, Travis County, Texas. I-35 from US 290 E to US 290 W/SH 71
Project Name and CSJ:	I-35 Capital Express Central Reconnaissance Survey - East Cesar Chavez Street Addendum, 0015-13-388
Address, Lat/Long:	1301 East Cesar Chavez Street, 30.259347/-97.731558
Function/Sub-function:	DOMESTIC/Single Dwelling (now COMMERCE/TRADE/Business)
Construction Date:	1898
Architectural Style/Form:	Queen Anne
NRHP Eligibility:	Individually listed (Criterion A: Commerce and Criterion C: Architecture); contributing to the recommended NRHP-eligible East 1st Historic District (Criteria A and C).
Description/Comments:	Two-story, L-plan, Queen Anne residence converted to commercial use. Hip roof with lower cross gables. Pier and beam foundation. Asphalt-shingle roof. Horizontal wood cladding with wood shingles in horizontal band at second floor and in gables. Two-story inset porch with front-gable extension. Wood sash windows. Rear addition. Architect J.J. Byrdson. Non-historic-age shed in rear. Resource 1026 is an Austin Historic Landmark. Resource 1026 is contributing to the recommended NRHP-eligible East 1st Street Historic District. It is individually listed in the NRHP under Criterion A in the area of Commerce and and Criterion C in the area of Architecture.

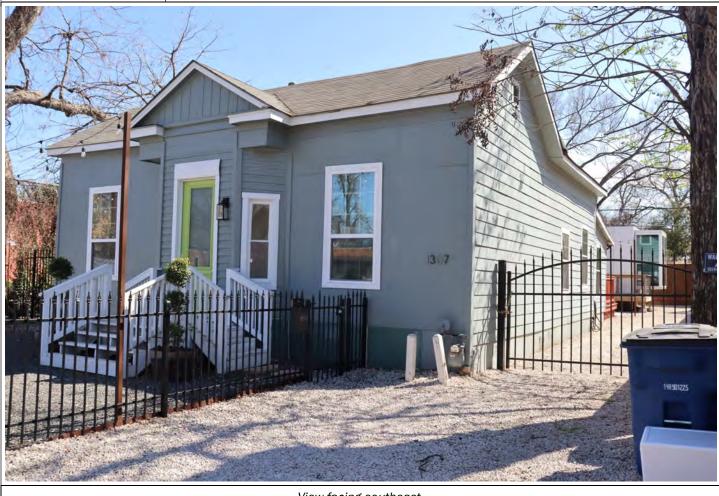
Survey Date:	March 28, 2022
Resource No.	1029
Project Location:	Austin, Travis County, Texas. I-35 from US 290 E to US 290 W/SH 71
Project Name and CSJ:	I-35 Capital Express Central Reconnaissance Survey - East Cesar Chavez Street Addendum, 0015-13-388
Address, Lat/Long:	1307 East Cesar Chavez Street, 30.259122/-97.731008
Function/Sub-function:	DOMESTIC/Single Dwelling
Construction Date:	1910
Architectural Style/Form:	No style
NRHP Eligibility:	Noncontributing to the recommended NRHP-eligible East 1st Street Historic District (Criteria A and C); not individually eligible.
Description/Comments:	One-story, rectangular-plan, side-gable residence with front gable over bay entry. Pier and beam foundation. Asphalt-shingle roof. Composite panel cladding with fiber cement cladding on side and horizontal wood in bay. Vinyl sash windows with small wood sash windows on bay. Historicage and non-historic-age additions on rear. Non-historic-age building in rear. Resource 1029 is noncontributing to the recommended NRHP-eligible East 1st Street Historic District and does not possess historical or architectural significance within the historic contexts necessary for individual listing in the NRHP under Criteria A, B, or C.

Integrity Considerations:	Alterations include replacement siding, windows, and doors, and altered fenestration. Due to alterations, Resource 1029 has lost integrity of design, materials, and workmanship. Resource 1029 retains integrity of location, setting, feeling, and association.

View facing southeast.

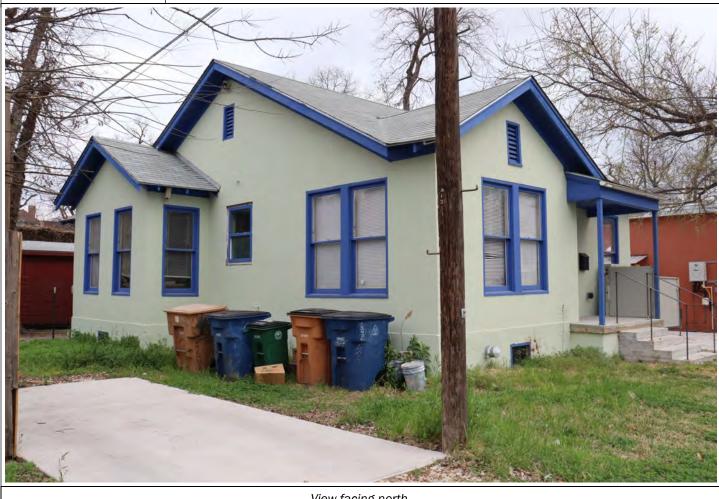
Survey Date:	March 29, 2022
Resource No.	1030B
Project Location:	Austin, Travis County, Texas. I-35 from US 290 E to US 290 W/SH 71
Project Name and CSJ:	I-35 Capital Express Central Reconnaissance Survey - East Cesar Chavez Street Addendum, 0015-13-388
Address, Lat/Long:	94 Navasota Street, 30.258917/-97.730850
Function/Sub-function:	DOMESTIC/Single Dwelling
Construction Date:	1937
Architectural Style/Form:	Minimal Traditional
NRHP Eligibility:	Individually eligible (Criterion A: Commerce; Criterion B: Significant Person; Criterion C: Architecture); contributing to the recommended NRHP-eligible East 1st Historic District (Criteria A and C).
Description/Comments:	One-story, rectangular-plan, cross-gable Minimal Traditional house. Pier and beam foundation. Asphalt-shingle roof. Stucco cladding. Wood sash windows. Shed awning over entry stoop. Non- historic-age shed in rear. Resource 1030B is contributing to the recommended NRHP-eligible East 1st Street Historic District. Resource 1030B is individually significant under Criterion A in the area of Commerce, Criterion B for association with William Johnson, a significant person in local history, and Criterion C in the area of Architecture. See HRSR text for detailed NRHP evaluation.

Integrity Considerations:	Alterations include replacement doors. Despite minor alterations, Resource 1030B retains all aspects of integrity.

View facing north.

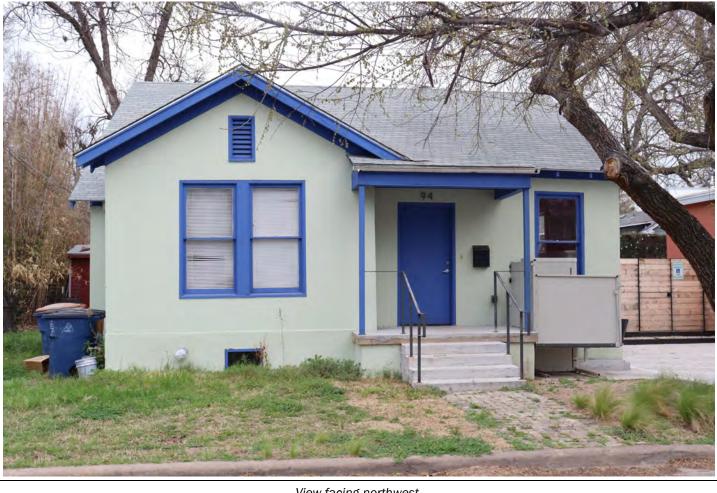
Survey Date:	March 29, 2022
Resource No.	1030B
Project Location:	Austin, Travis County, Texas. I-35 from US 290 E to US 290 W/SH 71
Project Name and CSJ:	I-35 Capital Express Central Reconnaissance Survey - East Cesar Chavez Street Addendum, 0015-13-388
Address, Lat/Long:	94 Navasota Street, 30.258917/-97.730850
Function/Sub-function:	DOMESTIC/Single Dwelling
Construction Date:	1937
Architectural Style/Form:	Minimal Traditional
NRHP Eligibility:	Individually eligible (Criterion A: Commerce; Criterion B: Significant Person; Criterion C: Architecture); contributing to the recommended NRHP-eligible East 1st Historic District (Criteria A and C).
Description/Comments:	One-story, rectangular-plan, cross-gable Minimal Traditional house. Pier and beam foundation. Asphalt-shingle roof. Stucco cladding. Wood sash windows. Shed awning over entry stoop. Non- historic-age shed in rear. Resource 1030B is contributing to the recommended NRHP-eligible East 1st Street Historic District. Resource 1030B is individually significant under Criterion A in the area of Commerce, Criterion B for association with William Johnson, a significant person in local history, and Criterion C in the area of Architecture. See HRSR text for detailed NRHP evaluation.

Integrity Considerations:	Alterations include replacement doors. Despite minor alterations, Resource 1030B retains all aspects of integrity.

View facing northwest.

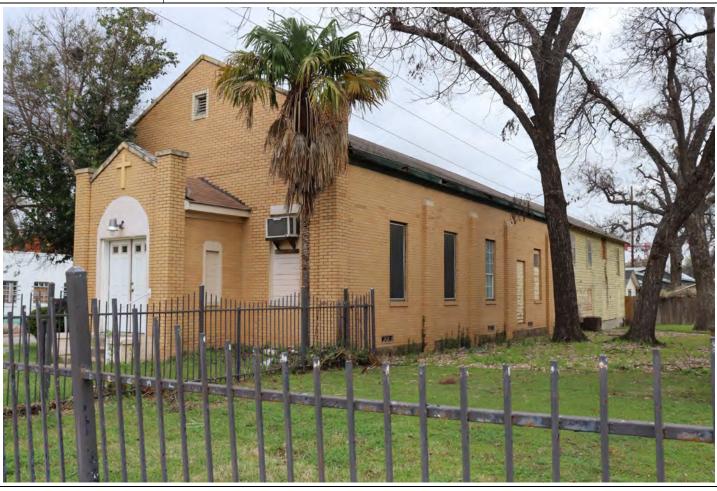
Survey Date:	March 29, 2022
Resource No.	1031
Project Location:	Austin, Travis County, Texas. I-35 from US 290 E to US 290 W/SH 71
Project Name and CSJ:	I-35 Capital Express Central Reconnaissance Survey - East Cesar Chavez Street Addendum, 0015-13-388
Address, Lat/Long:	1400 East Cesar Chavez Street, 30.259353/-97.730451
Function/Sub-function:	RELIGION/Religious Facility
Construction Date:	c.1925
Architectural Style/Form:	No style
NRHP Eligibility:	Not individually eligible but remains a historic property as a contributing resource to the recommended NRHP-eligible East 1st Street Historic District (Criteria A and C).
Description/Comments:	One-story, rectangular-plan, cross-gable church. Rear is two-story. Pier and beam foundation. Asphalt-shingle roof. Partial brick cladding on front and parts of sides with horizontal wood on side, asbestos shingles on rear. Vinyl- and wood sash windows. Infilled windows on front and side. 1935 Sanborn map shows a frame building; 1962 Sanborn map shows the same building footprint with brick veneer on front and part of sides. Resource 1031 is contributing to the recommended NRHP-eligible East 1st Street Historic District. However, it does not possess historical or architectural significance within the historic contexts necessary for individual listing in the NRHP under Criteria A, B, or C.

Integrity Considerations:	Alterations include replacement windows and doors and infill in some windows. Despite minor alterations, Resource 1031 retains all aspects of integrity.

View facing northwest.

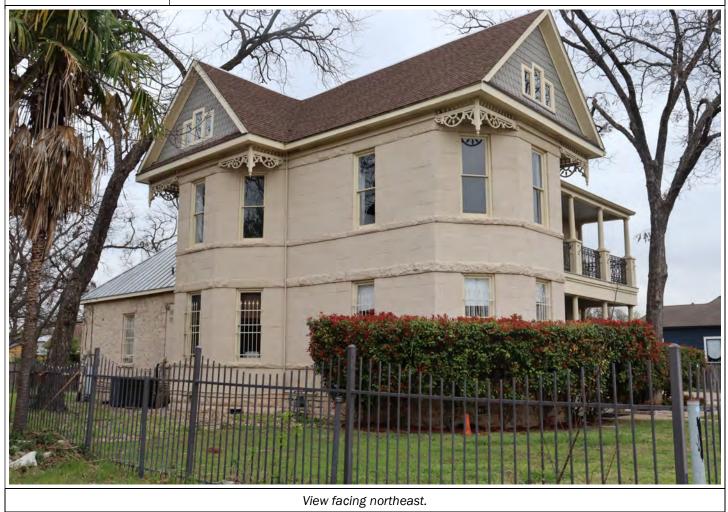
Survey Date:	March 29, 2022
Resource No.	1032
Project Location:	Austin, Travis County, Texas. I-35 from US 290 E to US 290 W/SH 71
Project Name and CSJ:	I-35 Capital Express Central Reconnaissance Survey - East Cesar Chavez Street Addendum, 0015-13-388
Address, Lat/Long:	1402 East Cesar Chavez Street, 30.259306/-97.730252
Function/Sub-function:	DOMESTIC/Single Dwelling (now COMMERCE/TRADE/Professional)
Construction Date:	1899
Architectural Style/Form:	Queen Anne
NRHP Eligibility:	Individually listed (Criterion C: Architecture); contributing to the recommended NRHP-eligible East 1st Street Historic District (Criteria A and C).
Description/Comments:	Two-story, L-plan, cross-gable, Queen Anne residence with one-story rear addition. Masonry foundation with load-bearing rustic and ashlar limestone walls. Asphalt-shingle roof on main house with metal roof on rear addition. Two-story flat-roof porch. Wood-sash and fixed wood windows. Resource 1032 is contributing to the recommended NRHP-eligible East 1st Street Historic District. It is individually listed in the NRHP under Criterion C in the area of Architecture.

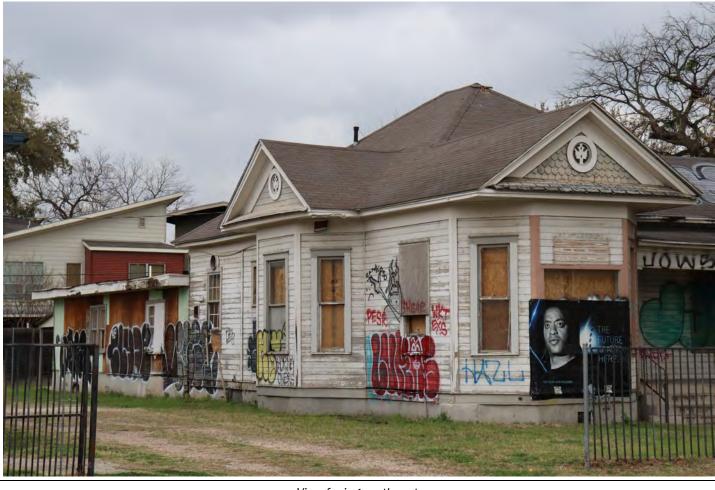
Survey Date:	March 29, 2022
Resource No.	1034
Project Location:	Austin, Travis County, Texas. I-35 from US 290 E to US 290 W/SH 71
Project Name and CSJ:	I-35 Capital Express Central Reconnaissance Survey - East Cesar Chavez Street Addendum, 0015-13-388
Address, Lat/Long:	1410 East Cesar Chavez Street, 30.259077/-97.729687
Function/Sub-function:	DOMESTIC/Single Dwelling (now VACANT/Not in Use)
Construction Date:	1905
Architectural Style/Form:	Folk Victorian
NRHP Eligibility:	Not individually eligible but remains a historic property as a contributing resource to the recommended NRHP-eligible East 1st Street Historic District (Criteria A and C).
Description/Comments:	One-story, L-plan, hip-roof, Folk Victorian residence with cross gables. Pier and beam foundation. Asphalt-shingle roof. Horizontal wood and plywood cladding. Wood and vinyl sash windows. Wrap around shed-roof porch. Historic-age flat-roof addition. Resource 1034 is contributing to the recommended NRHP-eligible East 1st Street Historic District. However, it does not possess historical or architectural significance within the historic contexts necessary for individual listing in the NRHP under Criteria A, B, or C.

Integrity Considerations:	Alterations include replacement of some windows, doors, and siding. Fenestration altered in front bay. Wood access ramp added to porch. Due to alterations, Resource 1034 has diminished integrity of materials and design. Resource 1034 retains integrity of location, setting, workmanship, feeling, and association.

View facing northeast.

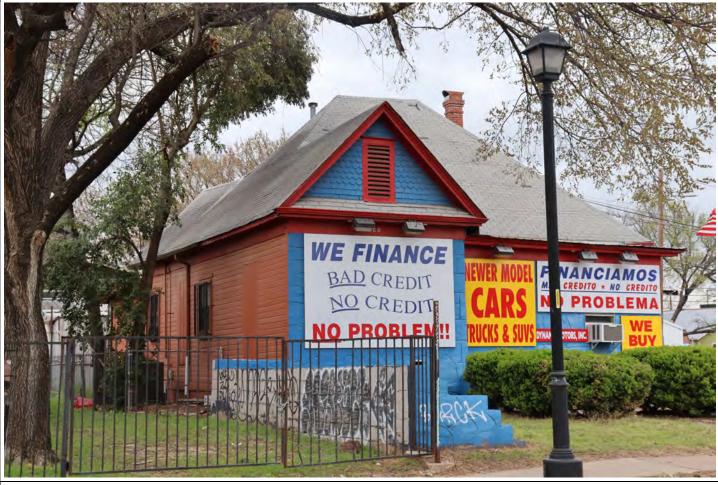
Survey Date:	March 29, 2022
Resource No.	1035
Project Location:	Austin, Travis County, Texas. I-35 from US 290 E to US 290 W/SH 71
Project Name and CSJ:	I-35 Capital Express Central Reconnaissance Survey - East Cesar Chavez Street Addendum, 0015-13-388
Address, Lat/Long:	1500 East Cesar Chavez Street, 30.259019/-97.729472
Function/Sub-function:	DOMESTIC/Single Dwelling (now COMMERCE/TRADE/Business)
Construction Date:	c.1905
Architectural Style/Form:	No style
NRHP Eligibility:	Noncontributing to the recommended NRHP-eligible East 1st Street Historic District (Criteria A and C); not individually eligible.
Description/Comments:	One-story, rectangular-plan, hip-roof residence with cross gables converted to commercial use. Pier and beam foundation. Asphalt-shingle roof. Stucco and horizontal wood cladding. Wood shingles in gable end on facade. Metal-sash and fixed wood windows. Shed-roof side addition. Metal canopies on parcel. Resource 1035 is noncontributing to the recommended NRHP-eligible East 1st Street Historic District and does not possess historical or architectural significance within the historic contexts necessary for individual listing in the NRHP under Criteria A, B, or C.

Integrity Considerations:	Alterations include replacement cladding, windows, and doors. Porch infilled. Fenestration altered. Due to major alterations, Resource 1035 has lost integrity of design, materials, workmanship, and feeling. Due to surrounding non-historic-age development, Resource 1035 has lost integrity of setting. Resource 1035 retains integrity of location and association.

View facing northeast.

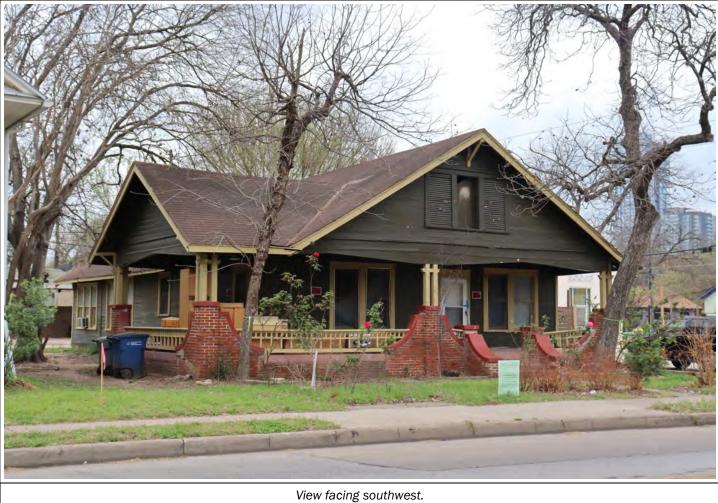
Survey Date:	March 29, 2022
Resource No.	1037
Project Location:	Austin, Travis County, Texas. I-35 from US 290 E to US 290 W/SH 71
Project Name and CSJ:	I-35 Capital Express Central Reconnaissance Survey - East Cesar Chavez Street Addendum, 0015-13-388
Address, Lat/Long:	1403 East Cesar Chavez Street, 30.258823/-97.730333
Function/Sub-function:	DOMESTIC/Single Dwelling
Construction Date:	1925
Architectural Style/Form:	Craftsman
NRHP Eligibility:	Individually eligible (Criterion C: Architecture); contributing to the recommended NRHP-eligible East 1st Street Historic District (Criteria A and C).
Description/Comments:	One-story, rectangular-plan, front-gable, Craftsman-style residence. Pier and beam foundation. Asphalt-shingle roof. Horizontal wood cladding. Cross-gable wraparound porch with sloped brick piers and wood supports with mortise-and-tenon detail. Intricate milled porch railing reminiscent of earlier styles like Queen Anne and Stick. One-over-one wood sash windows. Resource 1037 is contributing to the recommended NRHP-eligible East 1st Street Historic District. It is individually significant under Criterion C in the area of Architecture. It does not possess historical significance within the historic contexts necessary for individual eligibility under Criteria A or B.

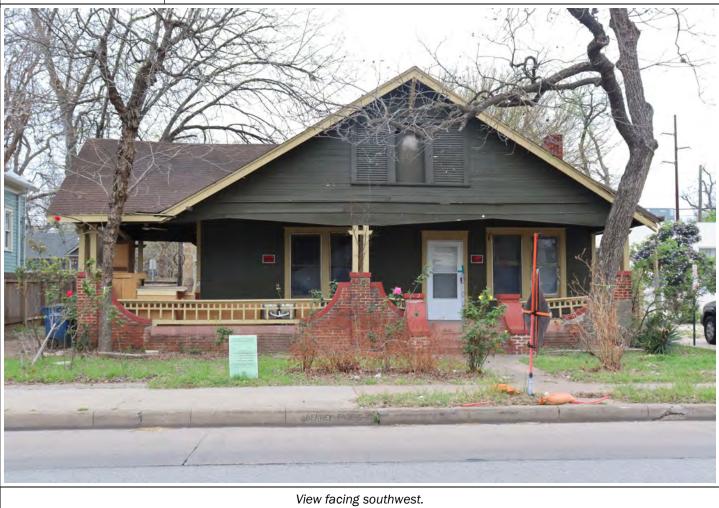
Survey Date:	March 29, 2022
Resource No.	1037
Project Location:	Austin, Travis County, Texas. I-35 from US 290 E to US 290 W/SH 71
Project Name and CSJ:	I-35 Capital Express Central Reconnaissance Survey - East Cesar Chavez Street Addendum, 0015-13-388
Address, Lat/Long:	1403 East Cesar Chavez Street, 30.258823/-97.730333
Function/Sub-function:	DOMESTIC/Single Dwelling
Construction Date:	1925
Architectural Style/Form:	Craftsman
NRHP Eligibility:	Individually eligible (Criterion C: Architecture); contributing to the recommended NRHP-eligible East 1st Street Historic District (Criteria A and C).
Description/Comments:	One-story, rectangular-plan, front-gable, Craftsman-style residence. Pier and beam foundation. Asphalt-shingle roof. Horizontal wood cladding. Cross-gable wraparound porch with sloped brick piers and wood supports with mortise-and-tenon detail. Intricate milled porch railing reminiscent of earlier styles like Queen Anne and Stick. One-over-one wood sash windows. Resource 1037 is contributing to the recommended NRHP-eligible East 1st Street Historic District. It is individually significant under Criterion C in the area of Architecture. It does not possess historical significance within the historic contexts necessary for individual eligibility under Criteria A or B.

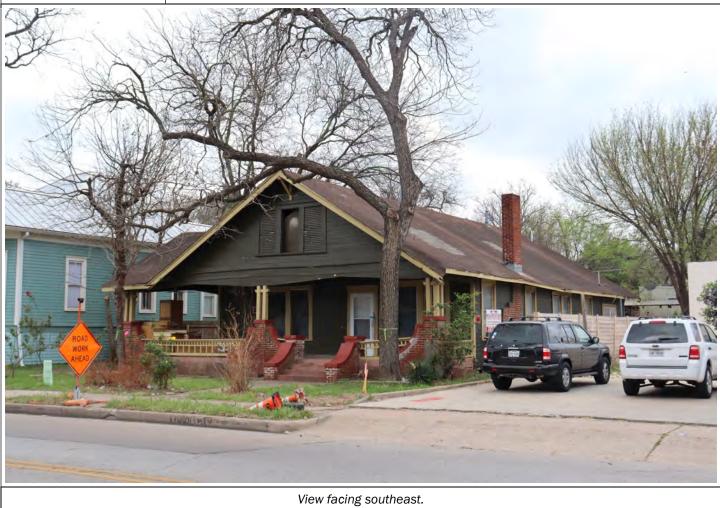
Survey Date:	March 29, 2022
Resource No.	1038
Project Location:	Austin, Travis County, Texas. I-35 from US 290 E to US 290 W/SH 71
Project Name and CSJ:	I-35 Capital Express Central Reconnaissance Survey - East Cesar Chavez Street Addendum, 0015-13-388
Address, Lat/Long:	1405 East Cesar Chavez Street, 30.258779/-97.730136
Function/Sub-function:	DOMESTIC/Single Dwelling
Construction Date:	1891
Architectural Style/Form:	Folk Victorian
NRHP Eligibility:	Individually eligible (Criterion C: Architecture); contributing to the recommended NRHP-eligible East 1st Street Historic District (Criteria A and C).
Description/Comments:	One-story, L-plan, hip-roof, Folk Victorian residence with cross gables. Pier and beam foundation with flared skirting. Metal roof. Horizontal wood cladding with fiber cement on foundation skirting. Fishscale shingles in gables. Two-over-two and one-over-one wood sash windows. Flat-roof porch, side addition. Resource 1038 is an Austin Historic Landmark. It is contributing to the recommended NRHP-eligible East 1st Street Historic District. Resource 1038 is individually significant under Criterion C in the area of Architecture. It does not possess historical significance within the historic contexts necessary for individual eligibility under Criteria A or B. See HRSR text for detailed NRHP evaluation.

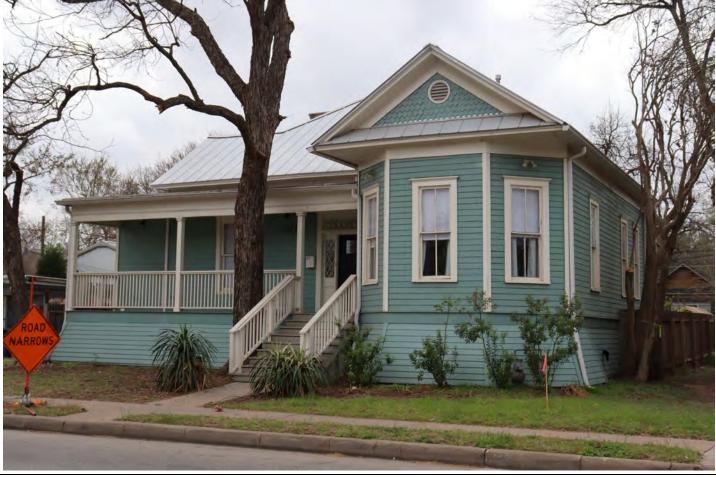
Survey Date:	March 29, 2022
Resource No.	1038
Project Location:	Austin, Travis County, Texas. I-35 from US 290 E to US 290 W/SH 71
Project Name and CSJ:	I-35 Capital Express Central Reconnaissance Survey - East Cesar Chavez Street Addendum, 0015-13-388
Address, Lat/Long:	1405 East Cesar Chavez Street, 30.258779/-97.730136
Function/Sub-function:	DOMESTIC/Single Dwelling
Construction Date:	1891
Architectural Style/Form:	Folk Victorian
NRHP Eligibility:	Individually eligible (Criterion C: Architecture); contributing to the recommended NRHP-eligible East 1st Street Historic District (Criteria A and C).
Description/Comments:	One-story, L-plan, hip-roof, Folk Victorian residence with cross gables. Pier and beam foundation with flared skirting. Metal roof. Horizontal wood cladding with fiber cement on foundation skirting. Fishscale shingles in gables. Two-over-two and one-over-one wood sash windows. Flat-roof porch, side addition. Resource 1038 is an Austin Historic Landmark. It is contributing to the recommended NRHP-eligible East 1st Street Historic District. Resource 1038 is individually significant under Criterion C in the area of Architecture. It does not possess historical significance within the historic contexts necessary for individual eligibility under Criteria A or B. See HRSR text for detailed NRHP evaluation.

Integrity Considerations:	Alterations include infill of wraparound porch on side that connects to side addition and replacement siding on foundation skirt. Despite minor alterations, Resource 1038 retains all aspects of integrity.
XXXX

View facing southeast.

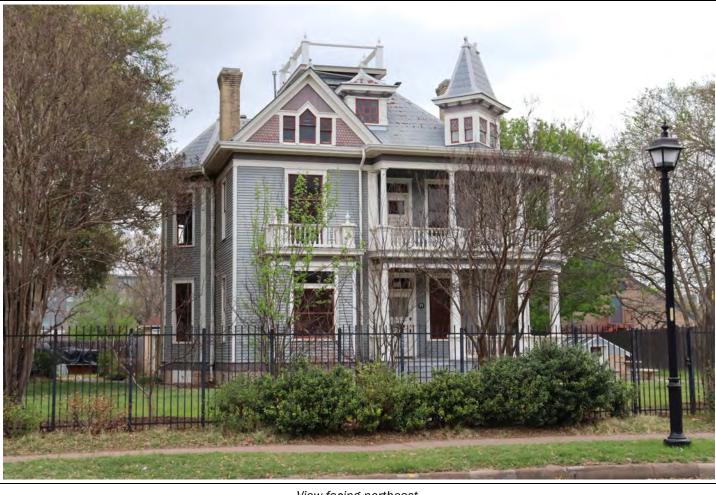
Survey Date:	March 29, 2022
Resource No.	1041A
Project Location:	Austin, Travis County, Texas. I-35 from US 290 E to US 290 W/SH 71
Project Name and CSJ:	I-35 Capital Express Central Reconnaissance Survey - East Cesar Chavez Street Addendum, 0015-13-388
Address, Lat/Long:	1602 East Cesar Chavez Street, 30.258615/-97.728192
Function/Sub-function:	DOMESTIC/Single Dwelling (now RECREATION and CULTURE/Event Space)
Construction Date:	1903
Architectural Style/Form:	Queen Anne
NRHP Eligibility:	Individually eligible (Criterion C: Architecture); contributing to the recommended NRHP-eligible East 1st Street Historic District (Criteria A and C).
Description/Comments:	Two-and-one-half-story, irregular-plan, hip-roof, Queen Anne residence with lower gables. Pier and beam foundation with brick skirting. Metal roof with deck on top of hip, turret, and dormer. Horizontal wood cladding with fishscale and vertical wood cladding in gables. Two-story, partial wraparound porch with flat roof. Wood-sash windows. Small one-story rear addition. Resource 1041 is an Austin Historic Landmark. It is contributing to the recommended NRHP-eligible East 1st Street Historic District. Resouce 1041A is individually significant under Criterion C in the area of Architecture. It does not possess historical significance within the historic contexts necessary for individual eligibility under Criteria A or B. See HRSR text for detailed NRHP evaluation.

Integrity Considerations:	There are no visible alterations. Use has changed from residential to commercial. Due to surrounding non-historic-age development, Resource 1041A has diminished integrity of setting. Resource 1041A retains integrity of location, design, materials, workmanship, association, and feeling.

View facing northeast.

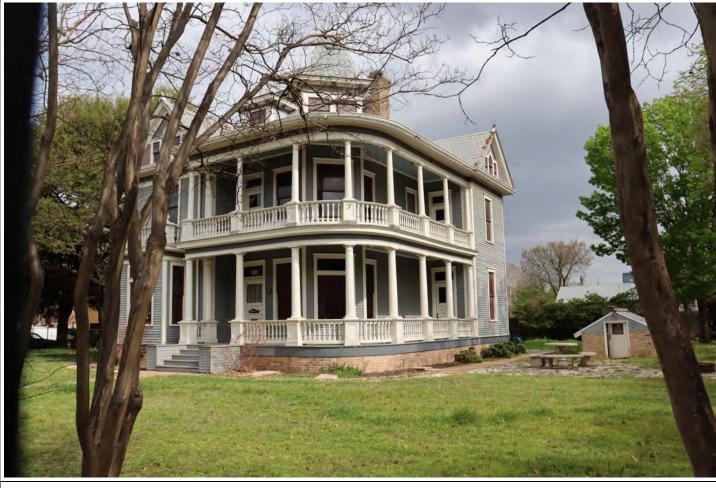
Survey Date:	March 29, 2022
Resource No.	1041A
Project Location:	Austin, Travis County, Texas. I-35 from US 290 E to US 290 W/SH 71
Project Name and CSJ:	I-35 Capital Express Central Reconnaissance Survey - East Cesar Chavez Street Addendum, 0015-13-388
Address, Lat/Long:	1602 East Cesar Chavez Street, 30.258615/-97.728192
Function/Sub-function:	DOMESTIC/Single Dwelling (now RECREATION and CULTURE/Event Space)
Construction Date:	1903
Architectural Style/Form:	Queen Anne
NRHP Eligibility:	Individually eligible (Criterion C: Architecture); contributing to the recommended NRHP-eligible East 1st Street Historic District (Criteria A and C).
Description/Comments:	Two-and-one-half-story, irregular-plan, hip-roof, Queen Anne residence with lower gables. Pier and beam foundation with brick skirting. Metal roof with deck on top of hip, turret, and dormer. Horizontal wood cladding with fishscale and vertical wood cladding in gables. Two-story, partial wraparound porch with flat roof. Wood-sash windows. Small one-story rear addition. Resource 1041 is an Austin Historic Landmark. It is contributing to the recommended NRHP-eligible East 1st Street Historic District. Resouce 1041A is individually significant under Criterion C in the area of Architecture. It does not possess historical significance within the historic contexts necessary for individual eligibility under Criteria A or B. See HRSR text for detailed NRHP evaluation.

Integrity Considerations:	There are no visible alterations. Use has changed from residential to commercial. Due to surrounding non-historic-age development, Resource 1041A has diminished integrity of setting. Resource 1041A retains integrity of location, design, materials, workmanship, association, and feeling.

View facing northwest.

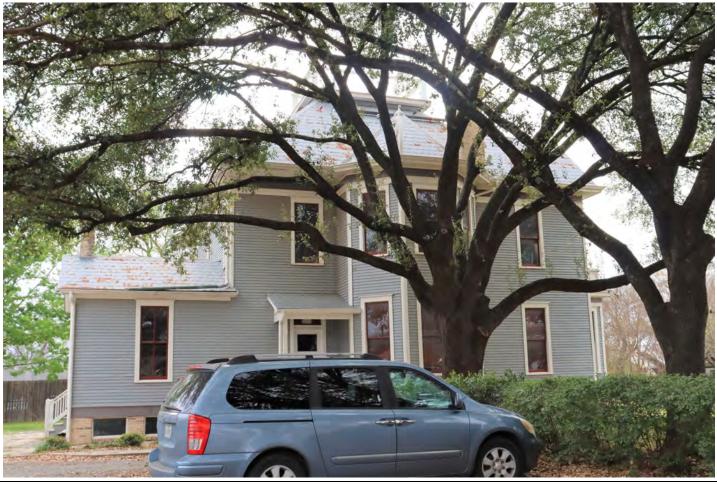
Survey Date:	March 29, 2022
Resource No.	1041A
Project Location:	Austin, Travis County, Texas. I-35 from US 290 E to US 290 W/SH 71
Project Name and CSJ:	I-35 Capital Express Central Reconnaissance Survey - East Cesar Chavez Street Addendum, 0015-13-388
Address, Lat/Long:	1602 East Cesar Chavez Street, 30.258615/-97.728192
Function/Sub-function:	DOMESTIC/Single Dwelling (now RECREATION and CULTURE/Event Space)
Construction Date:	1903
Architectural Style/Form:	Queen Anne
NRHP Eligibility:	Individually eligible (Criterion C: Architecture); contributing to the recommended NRHP-eligible East 1st Street Historic District (Criteria A and C).
Description/Comments:	Two-and-one-half-story, irregular-plan, hip-roof, Queen Anne residence with lower gables. Pier and beam foundation with brick skirting. Metal roof with deck on top of hip, turret, and dormer. Horizontal wood cladding with fishscale and vertical wood cladding in gables. Two-story, partial wraparound porch with flat roof. Wood-sash windows. Small one-story rear addition. Resource 1041 is an Austin Historic Landmark. It is contributing to the recommended NRHP-eligible East 1st Street Historic District. Resouce 1041A is individually significant under Criterion C in the area of Architecture. It does not possess historical significance within the historic contexts necessary for individual eligibility under Criteria A or B. See HRSR text for detailed NRHP evaluation.

Integrity Considerations:	There are no visible alterations. Use has changed from residential to commercial. Due to surrounding non-historic-age development, Resource 1041A has diminished integrity of setting. Resource 1041A retains integrity of location, design, materials, workmanship, association, and feeling.

View facing southeast.

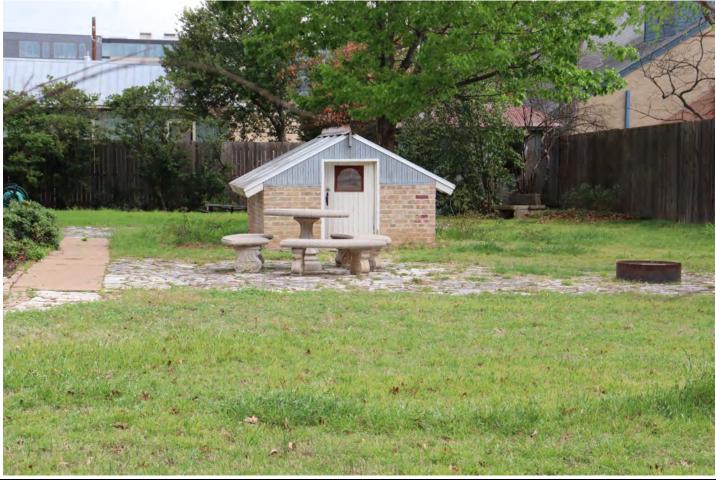
Survey Date:	March 29, 2022
Resource No.	1041D
Resource No.	
Project Location:	Austin, Travis County, Texas. I-35 from US 290 E to US 290 W/SH 71
Project Name and CSJ:	I-35 Capital Express Central Reconnaissance Survey - East Cesar Chavez Street Addendum, 0015-13-388
Address, Lat/Long:	1602 East Cesar Chavez Street, 30.258566/-97.728043
Function/Sub-function:	DOMESTIC/Secondary Structure (now RECREATION and CULTURE/Outbuilding)
Construction Date:	c.1905
Architectural Style/Form:	No style
NRHP Eligibility:	Individually eligible (Criterion C: Architecture); contributing to the recommended NRHP-eligible East 1st Street Historic District (Criteria A and C).
Description/Comments:	One-story, rectangular-plan, front-gable greenhouse. Partially underground. Metal-framed glass roof. Brick and vertical wood cladding. Resource 1041 is an Austin Historic Landmark. It is contributing to the recommended NRHP-eligible East 1st Street Historic District. Resouce 1041D is individually significant under Criterion C in the area of Architecture. It does not possess historical significance within the historic contexts necessary for individual eligibility under Criteria A or B. See HRSR text for detailed NRHP evaluation.

Integrity Considerations:	There are no visible alterations. The 1979 City of Austin Historic Landmark nomination says the owners planned to renovate the building, called out as the hothouse. Due to surrounding non-historic-age development, Resource 1041D has diminished integrity of setting. Resource 1041D retains integrity of location, design, materials, workmanship, association, and feeling.

View facing northeast.

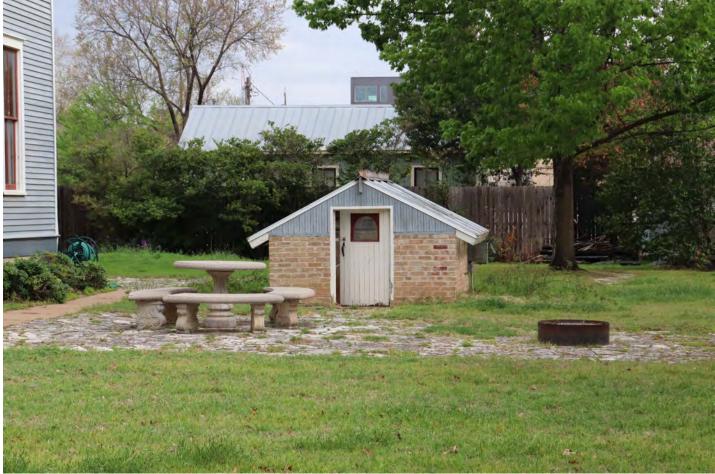
$\label{eq:View facing northwest. Showing relationship between 1041A (left) and 1041D (right).$

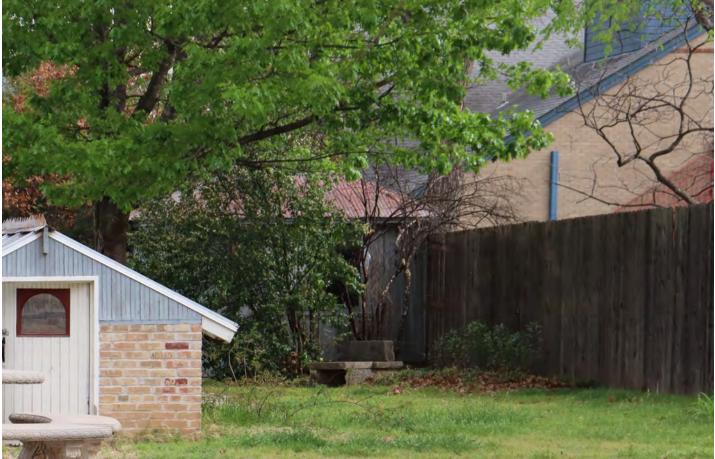
March 29, 2022
1041E
Austin, Travis County, Texas. I-35 from US 290 E to US 290 W/SH 71
I-35 Capital Express Central Reconnaissance Survey - East Cesar Chavez Street Addendum, 0015-13-388
1602 East Cesar Chavez Street, 30.258869/-97.727930
DOMESTIC/Secondary Structure (now RECREATION and CULTURE/Outbuilding)
c.1905
No style
Individually eligible (Criterion C: Architecture); contributing to the recommended NRHP-eligible East 1st Street Historic District (Criteria A and C).
One-story, rectangular-plan, hip roof building. Metal roof. Board and batten cladding. Resource 1041 is an Austin Historic Landmark. It is contributing to the recommended NRHP-eligible East 1st Street Historic District. Resouce 1041E is individually significant under Criterion C in the area of Architecture. It does not possess historical significance within the historic contexts necessary for individual eligibility under Criteria A or B. See HRSR text for detailed NRHP evaluation.

There are no visible alterations. The 1979 City of Austin Historic Landmark nomination says the owners planned to renovate the building, called out as the laundry. Due to surrounding non-historic-age development, Resource 1041E has diminished integrity of setting. Resource 1041E retains integrity of location, design, materials, workmanship, association and feeling.

View facing northeast. Showing relationship between 1041D (left) and 1041E (right).

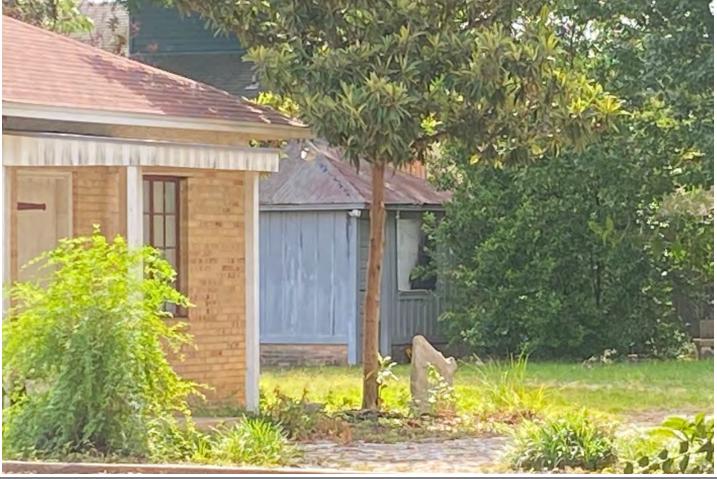
View facing east. Resource 1041E shown at center in image.

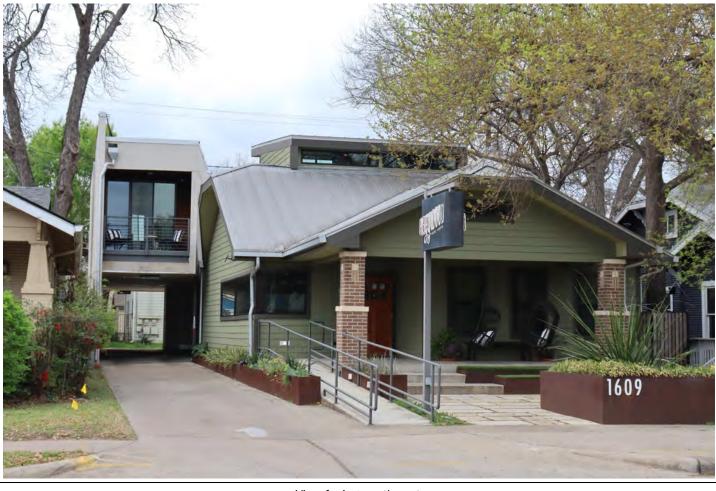
March 29, 2022 1044
1044
Austin, Travis County, Texas. I-35 from US 290 E to US 290 W/SH 71
I-35 Capital Express Central Reconnaissance Survey - East Cesar Chavez Street Addendum, 0015-13-388
1609 East Cesar Chavez Street, 30.258029/-97.727913
DOMESTIC/Single Dwelling (now Hotel)
1925
Craftsman
Not individually eligible but remains a historic property as a contributing resource to the recommended NRHP-eligible East 1st Street Historic District (Criteria A and C).
One-and-one-half-story, rectangular-plan, clipped side gable, Craftsman-style residence converted to a hotel. Pier and beam foundation. Metal roof. Fiber cement and stucco cladding. Partial front-gable porch. Vinyl sash and fixed vinyl windows. Non-historic-age second-story and rear additions. Resource 1044 is contributing to the recommended NRHP-eligible East 1st Street Historic District. However, it does not possess historical or architectural significance within the historic contexts necessary for individual listing in the NRHP under Criteria A, B, or C.

Alterations include replacement windows, siding, and doors. Non-historic-age additions. Altered fenestration and roofline. Due to these alterations, Resource 1044 has lost integrity of design, materials, workmanship, and feeling. Resource 1044 retains integrity of location, setting, and association.

View facing southwest.
