Appendix B: Tabular Inventory of Surveyed Properties

H Historical Studies Report, Texas Department of Transportation, Environmental Affairs Division

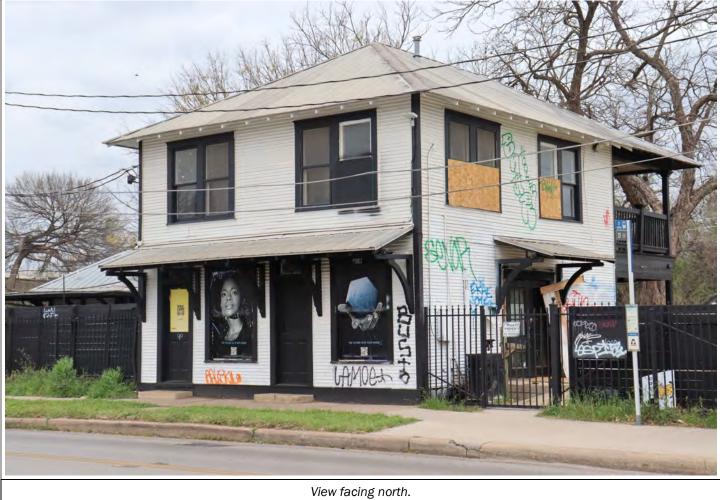
Survey Date:	March 29, 2022
Resource No.	1049A
Project Location:	Austin, Travis County, Texas. I-35 from US 290 E to US 290 W/SH 71
Project Name and CSJ:	I-35 Capital Express Central Reconnaissance Survey - East Cesar Chavez Street Addendum, 0015-13-388
Address, Lat/Long:	1808 East Cesar Chavez Street, 30.257365/-97.724914
Function/Sub-function:	DOMESTIC/COMMERCIAL/Multiple Dwelling/Business
Construction Date:	1925
Architectural Style/Form:	Craftsman
NRHP Eligibility:	Individually eligible (Criterion A: Commerce and Criterion C: Architecture); contributing to the recommended NRHP-eligible East 1st Street Historic District (Criteria A and C).
Description/Comments:	Two-story, rectangular-plan, hip-roof, Craftsman-style, mixed-use building. Pier and beam foundation. Metal roof. Horizontal wood cladding. Two separate wood, single-light, paneled entry doors on facade, French-door side entry on east elevation, enclosed entry on west elevation. Wood-sash windows. Non-historic-age two-story porch on rear elevation and non-historic-age hip-roof addition on west elevation. Metal pent awnings with wood brackets. Non-historic-age, hip-roof shed west of building. Resource 1049A is contributing to the recommended NRHP-eligible East 1st Street Historic District. Resource 1049A is individually significant under Criterion A in the area of Commerce and Criterion C in the area of Architecture. It does not possess historical significance within the historic contexts necessary for individual eligibility under Criterion B. See HRSR text for detailed NRHP evaluation.

Integrity Considerations:	Due to additions, Resource 1049A has lost integrity of design and feeling, but retains integrity of location, setting, materials, workmanship, and association.

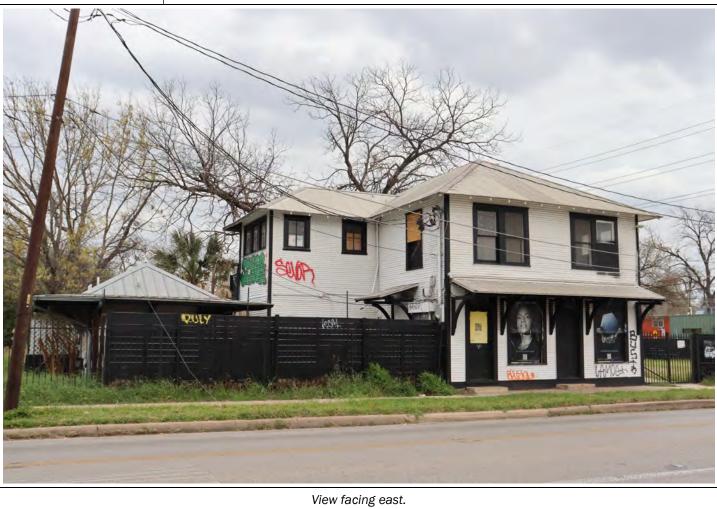
Survey Date:	March 29, 2022
Resource No.	1049A
Project Location:	Austin, Travis County, Texas. I-35 from US 290 E to US 290 W/SH 71
Project Name and CSJ:	I-35 Capital Express Central Reconnaissance Survey - East Cesar Chavez Street Addendum, 0015-13-388
Address, Lat/Long:	1808 East Cesar Chavez Street, 30.257365/-97.724914
Function/Sub-function:	DOMESTIC/COMMERCIAL/Multiple Dwelling/Business
Construction Date:	1925
Architectural Style/Form:	Craftsman
NRHP Eligibility:	Individually eligible (Criterion A: Commerce and Criterion C: Architecture); contributing to the recommended NRHP-eligible East 1st Street Historic District (Criteria A and C).
Description/Comments:	Two-story, rectangular-plan, hip-roof, Craftsman-style, mixed-use building. Pier and beam foundation. Metal roof. Horizontal wood cladding. Two separate wood, single-light, paneled entry doors on facade, French-door side entry on east elevation, enclosed entry on west elevation. Wood-sash windows. Non-historic-age two-story porch on rear elevation and non-historic-age hip-roof addition on west elevation. Metal pent awnings with wood brackets. Non-historic-age, hip-roof shed west of building. Resource 1049A is contributing to the recommended NRHP-eligible East 1st Street Historic District. Resource 1049A is individually significant under Criterion A in the area of Commerce and Criterion C in the area of Architecture. It does not possess historical significance within the historic contexts necessary for individual eligibility under Criterion B. See HRSR text for detailed NRHP evaluation.

Integrity Considerations:	Due to additions, Resource 1049A has lost integrity of design and feeling, but retains integrity of location, setting, materials, workmanship, and association.

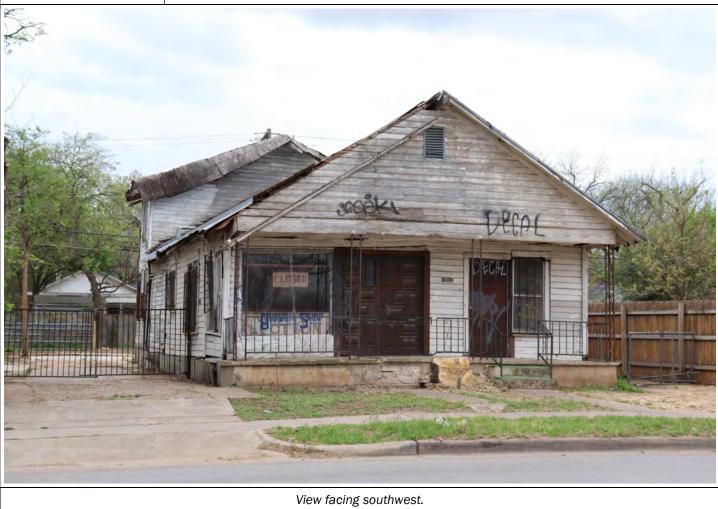
Survey Date:	March 29, 2022
Resource No.	1063A
Project Location:	Austin, Travis County, Texas. I-35 from US 290 E to US 290 W/SH 71
Project Name and CSJ:	I-35 Capital Express Central Reconnaissance Survey - East Cesar Chavez Street Addendum, 0015-13-388
Address, Lat/Long:	1913 East Cesar Chavez Street, 30.256611/-97.723702
Function/Sub-function:	DOMESTIC/Single Dwelling
Construction Date:	1916
Architectural Style/Form:	Bungalow
NRHP Eligibility:	Not individually eligible but remains a historic property as a contributing resource to the recommended NRHP-eligible East 1st Street Historic District (Criteria A and C).
Description/Comments:	One-story, rectangular-plan, front-gable bungalow. Pier and beam foundation. Asphalt-shingle roof. Horizontal wood and brick cladding. Partial front-gable porch. Vinyl sash windows. Wood carport on southeast side. Resource 1063A is contributing to the recommended NRHP-eligible East 1st Street Historic District. However, it does not possess historical or architectural significance within the historic contexts necessary for individual listing in the NRHP under Criteria A, B, or C.

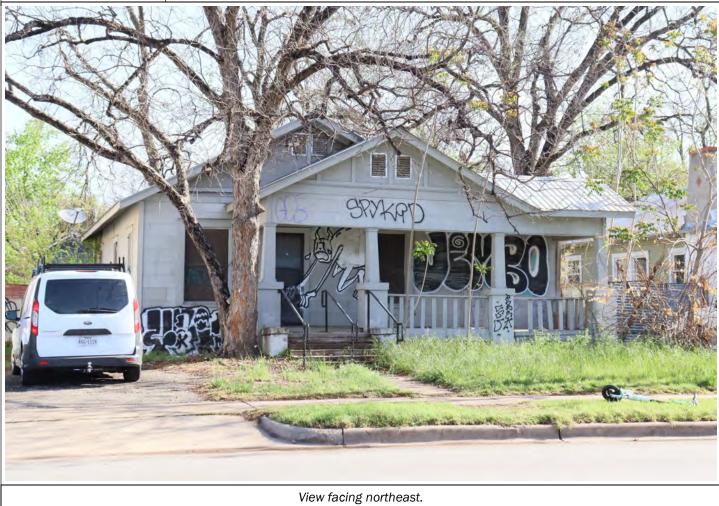
Survey Date:	March 30, 2022
Resource No.	1067
Project Location:	Austin, Travis County, Texas. I-35 from US 290 E to US 290 W/SH 71
Project Name and CSJ:	I-35 Capital Express Central Reconnaissance Survey - East Cesar Chavez Street Addendum, 0015-13-388
Address, Lat/Long:	2012 East Cesar Chavez Street, 30.256743/-97.722998
Function/Sub-function:	DOMESTIC/Single Dwelling
Construction Date:	1920
Architectural Style/Form:	Craftsman
NRHP Eligibility:	Not individually eligible but remains a historic property as a contributing resource to the recommended NRHP-eligible East 1st Street Historic District (Criteria A and C).
Description/Comments:	One-story, rectangular-plan, front-gable, Craftsman-stye residence converted to commercial use. Pier and beam foundation. Metal roof. Horizontal wood cladding. Wood sash and fixed vinyl windows. Porch enclosed with stucco-clad walls, fixed vinyl windows, and entry door. Non-historic- age shed in rear. Resource 1067 is contributing to the recommended NRHP-eligible East 1st Street Historic District. However, it does not possess historical or architectural significance within the historic contexts necessary for individual listing in the NRHP under Criteria A, B, or C.

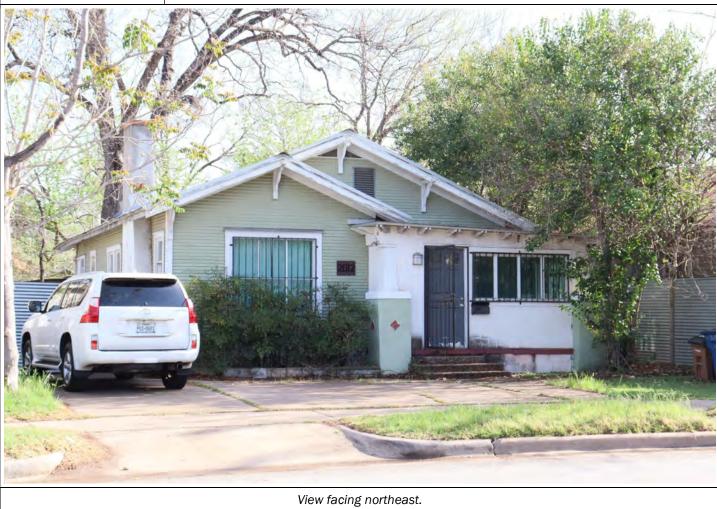
Survey Date:	March 30, 2022
Resource No.	1068
Project Location:	Austin, Travis County, Texas. I-35 from US 290 E to US 290 W/SH 71
Project Name and CSJ:	I-35 Capital Express Central Reconnaissance Survey - East Cesar Chavez Street Addendum, 0015-13-388
Address, Lat/Long:	2016 East Cesar Chavez Street, 30.256698/-97.722857
Function/Sub-function:	DOMESTIC/Single Dwelling
Construction Date:	c.1920
Architectural Style/Form:	Bungalow
NRHP Eligibility:	Not individually eligible but remains a historic property as a contributing resource to the recommended NRHP-eligible East 1st Street Historic District (Criteria A and C).
Description/Comments:	One-story, rectangular-plan, pyramidal-roof bungalow. Pier and beam foundation. Metal roof. Horizontal wood cladding. Replacement fixed metal windows. Resource 1068 is contributing to the recommended NRHP-eligible East 1st Street Historic District. However, it does not possess historical or architectural significance within the historic contexts necessary for individual listing in the NRHP under Criteria A, B, or C.

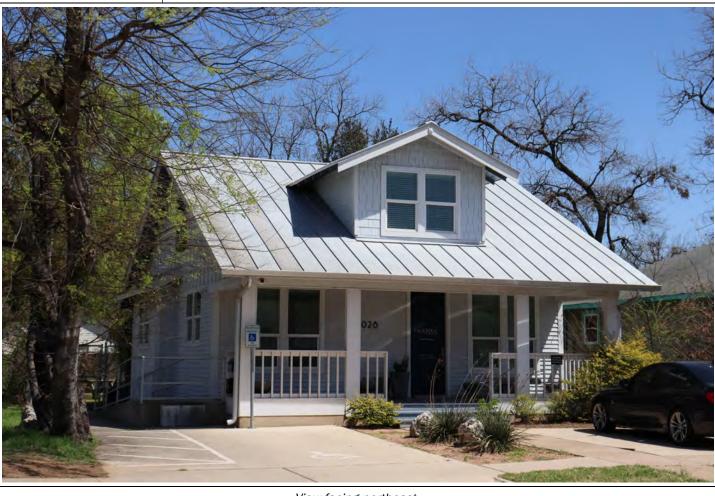
Survey Date:	March 30, 2022
Resource No.	1076
Project Location:	Austin, Travis County, Texas. I-35 from US 290 E to US 290 W/SH 71
Project Name and CSJ:	I-35 Capital Express Central Reconnaissance Survey - East Cesar Chavez Street Addendum, 0015-13-388
Address, Lat/Long:	2028 East Cesar Chavez Street, 30.256509/-97.722312
Function/Sub-function:	DOMESTIC/Single Dwelling (now COMMERCE/TRADE/Professional)
Construction Date:	1920
Architectural Style/Form:	Bungalow
NRHP Eligibility:	Not individually eligible but remains a historic property as a contributing resource to the recommended NRHP-eligible East 1st Street Historic District (Criteria A and C).
Description/Comments:	One-story, rectangular-plan, side-gable bungalow converted to office space. Pier and beam foundation. Horizontal wood siding, vinyl shingles in gables and dormer. Metal roof. Full-width, inset porch with simple box columns, large central dormer on front facade. 1/1 vinyl sash windows and fixed vinyl windows. Resource 1076 is contributing to the recommended NRHP-eligible East 1st Street Historic District. However, it does not possess historical or architectural significance within the historic contexts necessary for individual listing in the NRHP under Criteria A, B, or C.

Integrity Considerations:	Alterations include replacement door, windows, and siding, and access ramp added along west elevation. Due to alterations, Resource 1076 has lost integrity of workmanship. Resource 1076 retains integrity of location, design, setting, materials, feeling, and association.

View facing northeast.

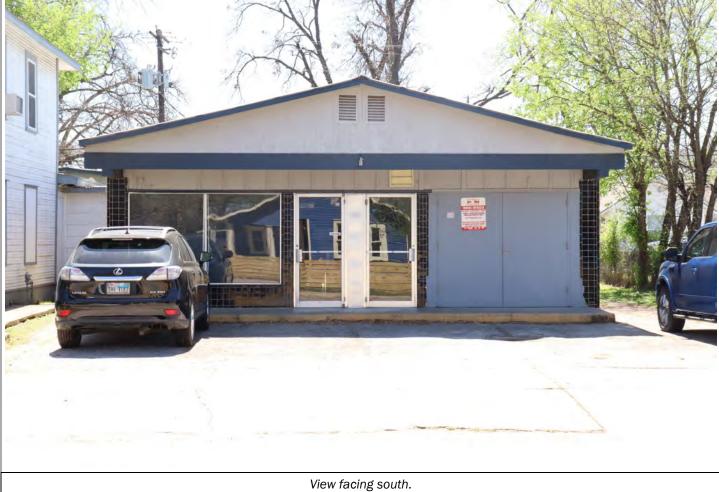
Survey Date:	March 30, 2022
Resource No.	1083
Project Location:	Austin, Travis County, Texas. I-35 from US 290 E to US 290 W/SH 71
Project Name and CSJ:	I-35 Capital Express Central Reconnaissance Survey - East Cesar Chavez Street Addendum, 0015-13-388
Address, Lat/Long:	2117 East Cesar Chavez Street, 30.255763/-97.721381
Function/Sub-function:	DOMESTIC/Single Dwelling (now COMMERCE/TRADE/Professional)
Construction Date:	1926
Architectural Style/Form:	American Foursquare
NRHP Eligibility:	Not individually eligible but remains a historic property as a contributing resource to the recommended NRHP-eligible East 1st Street Historic District (Criteria A and C).
Description/Comments:	Two-story, rectangular-plan, hip-roof, American Foursquare residence converted to office. Pier and beam foundation. Horizontal wood siding. Asphalt-shingle roof. Centered, partial-width, front- gable porch with simple wood post supports. 1/1 viny and wood sash windows; infilled windows on east elevation. Asymmetrical fenestration may indicate conversion from duplex to single dwelling. Historic-age, single-story addition on rear elevation. Resource 1083 is contributing to the recommended NRHP-eligible East 1st Street Historic District. However, it does not possess historical or architectural significance within the historic contexts necessary for individual listing in the NRHP under Criteria A, B, or C.

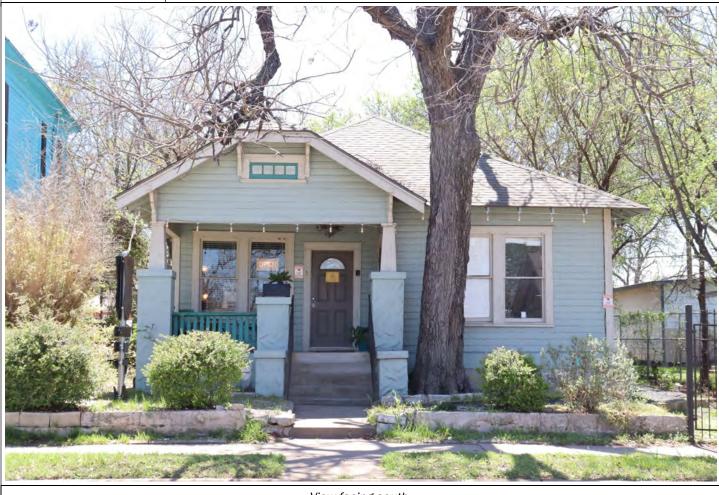
Survey Date:	March 30, 2022
Resource No.	1084
Project Location:	Austin, Travis County, Texas. I-35 from US 290 E to US 290 W/SH 71
Project Name and CSJ:	I-35 Capital Express Central Reconnaissance Survey - East Cesar Chavez Street Addendum, 0015-13-388
Address, Lat/Long:	2121 East Cesar Chavez Street, 30.255731/-97.721236
Function/Sub-function:	DOMESTIC/Single Dwelling (now COMMERCE/TRADE/Business)
Construction Date:	1928
Architectural Style/Form:	Craftsman
NRHP Eligibility:	Not individually eligible but remains a historic property as a contributing resource to the recommended NRHP-eligible East 1st Street Historic District (Criteria A and C).
Description/Comments:	One-story, rectangular-plan, hip-roof, Craftsman bungalow. Pier and beam foundation. Horizontal wood siding. Asphalt-shingle roof. Partial-width inset porch with clipped-gable roof and tapered box columns set on stone piers. 1/1 wood sash windows. Historic-age addition on rear elevation. Resource 1084 is contributing to the recommended NRHP-eligible East 1st Street Historic District. However, it does not possess historical or architectural significance within the historic contexts necessary for individual listing in the NRHP under Criteria A, B, or C.

Integrity Considerations:	Alterations are limited to a replacement door. Despite this minor alteration, Resource 1084 retains all aspects of integrity.

View facing south.

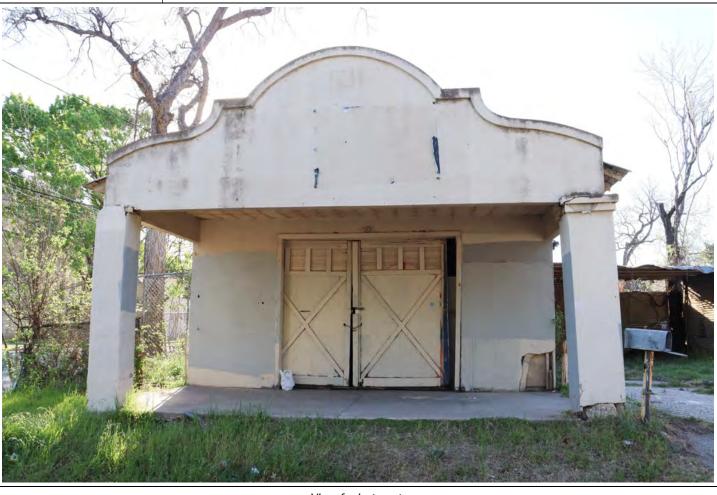
Survey Date:	March 31, 2022
Resource No.	1092
Project Location:	Austin, Travis County, Texas. I-35 from US 290 E to US 290 W/SH 71
Project Name and CSJ:	I-35 Capital Express Central Reconnaissance Survey - East Cesar Chavez Street Addendum, 0015-13-388
Address, Lat/Long:	101 Robert T. Martinez, Jr. Street, 30.256067/-97.720381
Function/Sub-function:	COMMERCE/TRADE/Gas Station (now VACANT/Not in Use)
Construction Date:	c.1920
Architectural Style/Form:	No style
NRHP Eligibility:	Not individually eligible but remains a historic property as a contributing resource to the recommended NRHP-eligible East 1st Street Historic District (Criteria A and C).
Description/Comments:	One-story, rectangular-plan, front-gable former gas station or auto shop building. Concrete slab foundation. Corrugated metal and stucco siding. Metal roof. Canopy extends from gable end of facade with decorative curved parapet. A pair of wood garage doors on facade with a second rolling metal garage door on the south elevation. Metal carport added on the south elevation. Resource 1092 is contributing to the recommended NRHP-eligible East 1st Street Historic District. However, it does not possess historical or architectural significance within the historic contexts necessary for individual listing in the NRHP under Criteria A, B, or C.

Integrity Considerations:	Alterations include replacement siding and garage door, and altered fenestration. Due to alterations, Resource 1092 has lost integrity of design, but retains integrity of location, setting, materials, workmanship, feeling, and association.

View facing east.

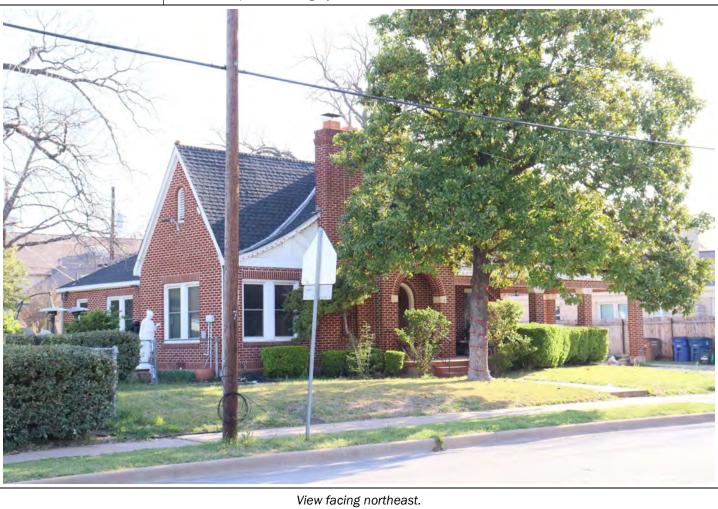
Survey Date:	March 31, 2022
Resource No.	1094B
Project Location:	Austin, Travis County, Texas. I-35 from US 290 E to US 290 W/SH 71
Project Name and CSJ:	I-35 Capital Express Central Reconnaissance Survey - East Cesar Chavez Street Addendum, 0015-13-388
Address, Lat/Long:	2214 East Cesar Chavez Street, 30.255874/-97.719805
Function/Sub-function:	DOMESTIC/Secondary Structure
Construction Date:	1936
Architectural Style/Form:	No style
NRHP Eligibility:	Not individually eligible but remains a historic property as a contributing resource to the recommended NRHP-eligible East 1st Street Historic District (Criteria A and C).
Description/Comments:	Two-story, rectangular-plan, hip-roof garage and secondary dwelling. Horizontal wood siding. Asphalt-shingle roof. Exterior metal stairs access second-story dwelling unit. 1/1 vinyl sash windows. Resource 1094B is contributing to the recommended NRHP-eligible East 1st Street Historic District. However, it does not possess historical or architectural significance within the historic contexts necessary for individual listing in the NRHP under Criteria A, B, or C.

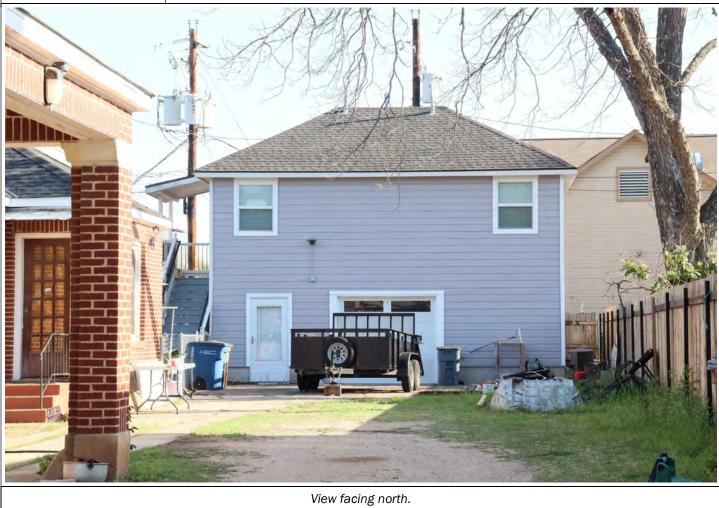
Survey Date:	March 31, 2022
Resource No.	1094C
Project Location:	Austin, Travis County, Texas. I-35 from US 290 E to US 290 W/SH 71
Project Name and CSJ:	I-35 Capital Express Central Reconnaissance Survey - East Cesar Chavez Street Addendum, 0015-13-388
Address, Lat/Long:	2214 East Cesar Chavez Street, 30.255935/-97.719983
Function/Sub-function:	DOMESTIC/Secondary Structure
Construction Date:	1955
Architectural Style/Form:	No style
NRHP Eligibility:	Not individually eligible but remains a historic property as a contributing resource to the recommended NRHP-eligible East 1st Street Historic District (Criteria A and C).
Description/Comments:	One-story, rectangular-plan, front-gable shed. Pier and beam foundation. Horizontal wood siding. Asphalt-shingle roof. Small, braced awning covers concrete stoop. One small metal sash window. Resource 1094C is contributing to the recommended NRHP-eligible East 1st Street Historic District. However, it does not possess historical or architectural significance within the historic contexts necessary for individual listing in the NRHP under Criteria A, B, or C.

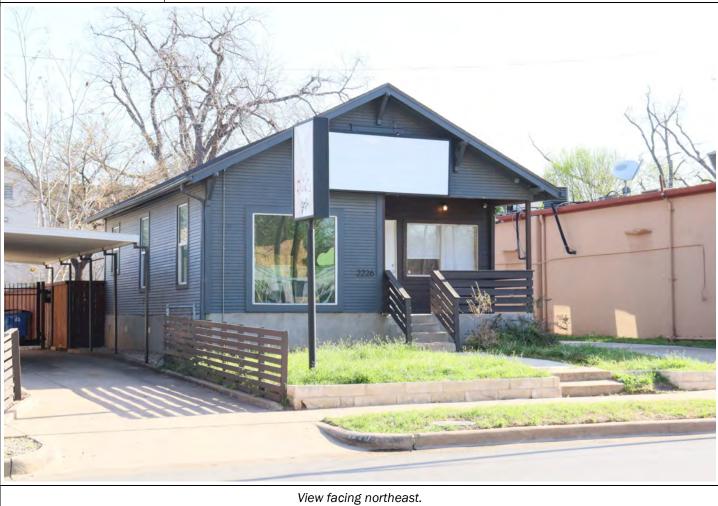
Survey Date:	March 31, 2022
Resource No.	1097
Project Location:	Austin, Travis County, Texas. I-35 from US 290 E to US 290 W/SH 71
Project Name and CSJ:	I-35 Capital Express Central Reconnaissance Survey - East Cesar Chavez Street Addendum, 0015-13-388
Address, Lat/Long:	2228 East Cesar Chavez Street, 30.255517/-97.719449
Function/Sub-function:	COMMERCE/TRADE/Business
Construction Date:	1952
Architectural Style/Form:	No style
NRHP Eligibility:	Noncontributing to the recommended NRHP-eligible East 1st Street Historic District (Criteria A and C); not individually eligible.
Description/Comments:	One-story, rectangular-plan, flat-roof building with pent metal awning. Concrete slab foundation. Concrete-block construction and stucco cladding. Fixed metal windows and metal-frame glass entry doors. Historic-age rear addition. Resource 1097 is noncontributing to the recommended NRHP-eligible East 1st Street Historic District and does not possess historical or architectural significance within the historic contexts necessary for individual listing in the NRHP under Criteria A, B, or C.

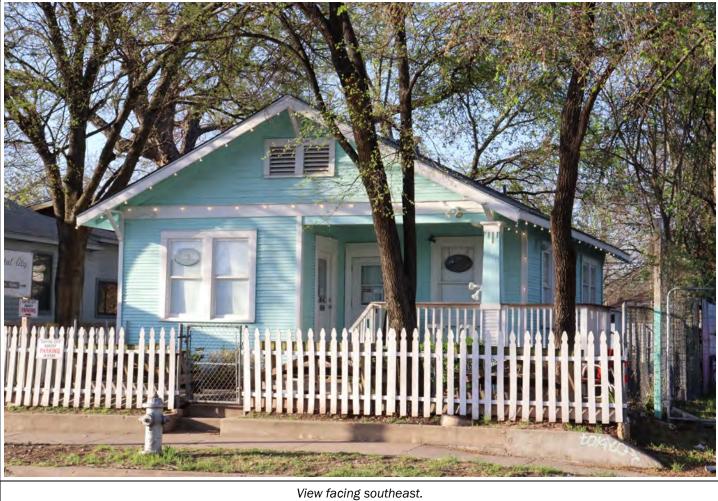
Survey Date:	March 31, 2022
Resource No.	1102
Project Location:	Austin, Travis County, Texas. I-35 from US 290 E to US 290 W/SH 71
Project Name and CSJ:	I-35 Capital Express Central Reconnaissance Survey - East Cesar Chavez Street Addendum, 0015-13-388
Address, Lat/Long:	2213 East Cesar Chavez Street, 30.255241/-97.719777
Function/Sub-function:	DOMESTIC/Single Dwelling (now COMMERCE/TRADE/Specialty Store)
Construction Date:	1905
Architectural Style/Form:	Bungalow
NRHP Eligibility:	Not individually eligible but remains a historic property as a contributing resource to the recommended NRHP-eligible East 1st Street Historic District (Criteria A and C).
Description/Comments:	One-story, rectangular-plan, pyramidal-roof bungalow converted for use as an art gallery. Pier and beam foundation. Horizontal wood and fiber cement siding. Asphalt-shingle roof. Full-width porch with metal shed roof and simple wood post supports. Original inset corner porch has been infilled, leaving a small opening for a recessed entryway. Metal fixed and sash windows. Large, two-story, non-historic-age addition on rear elevation. Resource 1102 is contributing to the recommended NRHP-eligible East 1st Street Historic District. However, it does not possess historical or architectural significance within the historic contexts necessary for individual listing in the NRHP under Criteria A, B, or C.

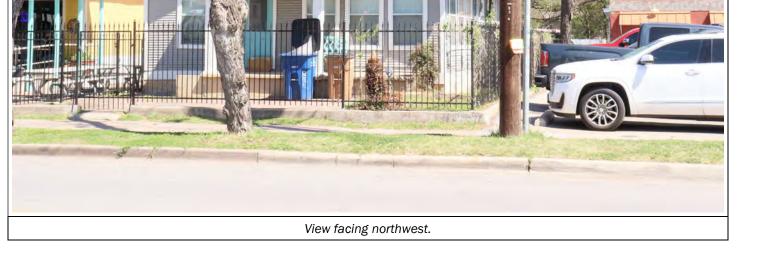
Survey Date:	March 31, 2022
Resource No.	1106
Project Location:	Austin, Travis County, Texas. I-35 from US 290 E to US 290 W/SH 71
Project Name and CSJ:	I-35 Capital Express Central Reconnaissance Survey - East Cesar Chavez Street Addendum, 0015-13-388
Address, Lat/Long:	2304 East Cesar Chavez Street, 30.255283/-97.718811
Function/Sub-function:	DOMESTIC/Single Dwelling (now VACANT/Not in Use)
Construction Date:	1920
Architectural Style/Form:	Bungalow
NRHP Eligibility:	Not individually eligible but remains a historic property as a contributing resource to the recommended NRHP-eligible East 1st Street Historic District (Criteria A and C).
Description/Comments:	One-story, rectangular-plan, front-gable bungalow. Pier and beam foundation. Metal roof. Horizontal and vertical wood cladding. Partial front-gable porch. Vinyl sash and sliding windows. Resource 1106 is contributing to the recommended NRHP-eligible East 1st Street Historic District. However, it does not possess historical or architectural significance within the historic contexts necessary for individual listing in the NRHP under Criteria A, B, or C.

Integrity Considerations:	Alterations include replacement windows and doors, and altered fenestration. Due to alterations, Resource 1106 has lost integrity of design, materials, and workmanship, but retains integrity of location, setting, feeling, and association.

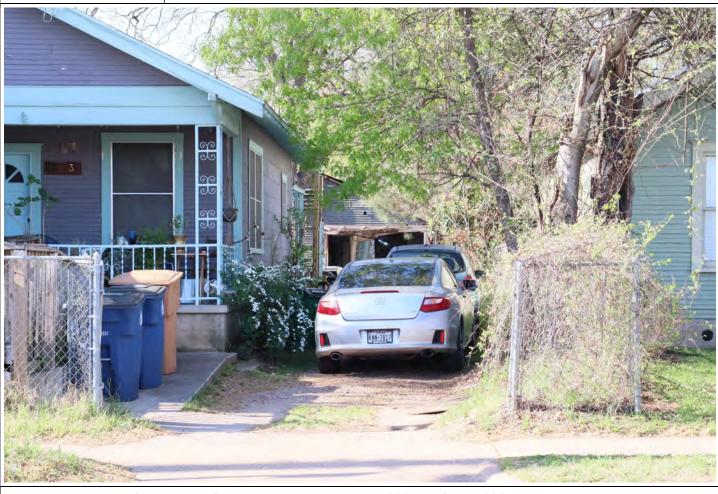
View facing south. Showing relationship between 1115A (left) and 1115B (back and right).

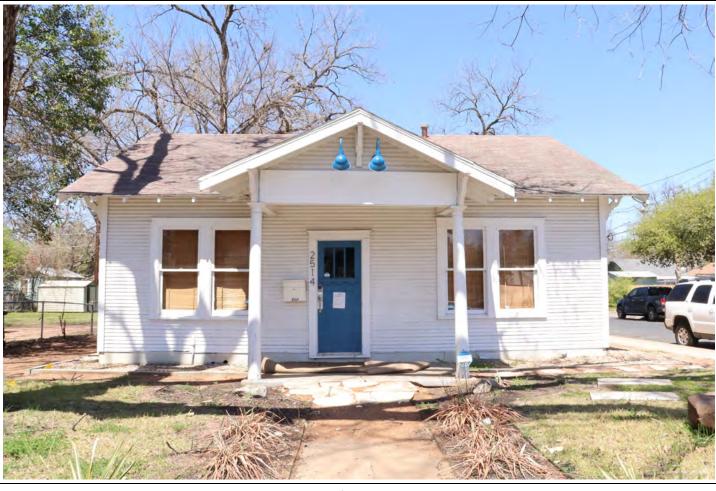
Survey Date:	March 31, 2022
Resource No.	1127A
Project Location:	Austin, Travis County, Texas. I-35 from US 290 E to US 290 W/SH 71
Project Name and CSJ:	I-35 Capital Express Central Reconnaissance Survey - East Cesar Chavez Street Addendum, 0015-13-388
Address, Lat/Long:	2514 East Cesar Chavez Street, 30.254116/-97.715509
Function/Sub-function:	DOMESTIC/Single Dwelling
Construction Date:	1925
Architectural Style/Form:	Bungalow
NRHP Eligibility:	Not individually eligible but remains a historic property as a contributing resource to the recommended NRHP-eligible East 1st Street Historic District (Criteria A and C).
Description/Comments:	One-story, rectangular-plan, side-gable bungalow. Pier and beam foundation. Horizontal wood siding. Asphalt-shingle roof. Gable-roof awning with Doric column supports, no stoop or porch. 1/1 wood sash windows. Resource 1127A is contributing to the recommended NRHP-eligible East 1st Street Historic District. However, it does not possess historical or architectural significance within the historic contexts necessary for individual listing in the NRHP under Criteria A, B, or C.

Integrity Considerations:	There are no visible alterations. Resource 1127A retains all aspects of integrity.

View facing north.

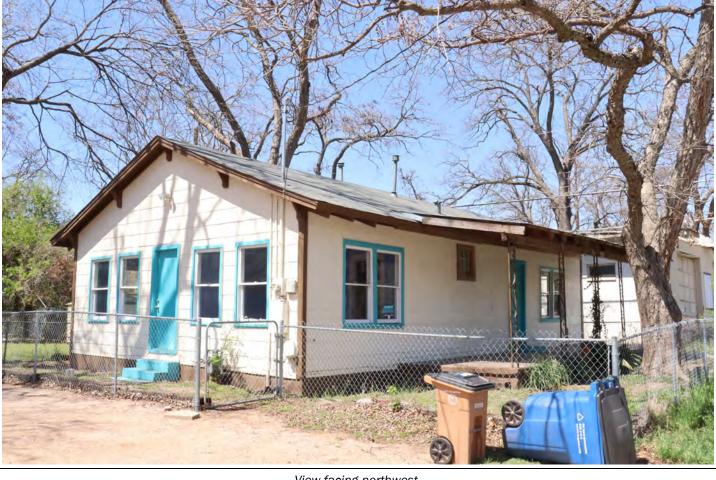
Survey Date:	March 31, 2022
Resource No.	1127B
Project Location:	Austin, Travis County, Texas. I-35 from US 290 E to US 290 W/SH 71
Project Name and CSJ:	I-35 Capital Express Central Reconnaissance Survey - East Cesar Chavez Street Addendum, 0015-13-388
Address, Lat/Long:	104 San Saba Street, 30.254361/-97.715376
Function/Sub-function:	DOMESTIC/Single Dwelling
Construction Date:	1925
Architectural Style/Form:	No style
NRHP Eligibility:	Not individually eligible but remains a historic property as a contributing resource to the recommended NRHP-eligible East 1st Street Historic District (Criteria A and C).
Description/Comments:	One-story, rectangular-plan, side-gable residence. Pier and beam foundation. Asbestos siding. Asphalt-shingle roof. Partial-width, shed-roof porch with iron supports. 1/1 wood sash and glass- block windows. Resource 1127B is contributing to the recommended NRHP-eligible East 1st Street Historic District. However, it does not possess historical or architectural significance within the historic contexts necessary for individual listing in the NRHP under Criteria A, B, or C.

Integrity Considerations:	Alterations are limited to replacement doors. Despite minor alterations, Resource 1127B retains all aspects of integrity.

View facing northwest.

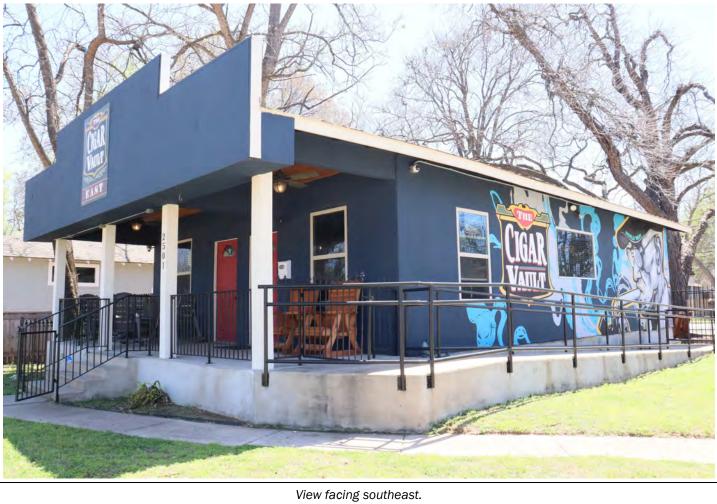
Survey Date:	March 31, 2022
Resource No.	1129
Project Location:	Austin, Travis County, Texas. I-35 from US 290 E to US 290 W/SH 71
Project Name and CSJ:	I-35 Capital Express Central Reconnaissance Survey - East Cesar Chavez Street Addendum, 0015-13-388
Address, Lat/Long:	2503 East Cesar Chavez Street, 30.254122/-97.716521
Function/Sub-function:	DOMESTIC/Single Dwelling
Construction Date:	1920
Architectural Style/Form:	Bungalow
NRHP Eligibility:	Not individually eligible but remains a historic property as a contributing resource to the recommended NRHP-eligible East 1st Street Historic District (Criteria A and C).
Description/Comments:	One-story, rectangular-plan, hip-roof bungalow with front-gable partial inset porch. Pier and beam foundation. Asphalt-shingle roof. Fiber cement cladding with wood shingles in gable. Vinyl sash and fixed vinyl windows. Shed-roof rear addition. Non-historic-age shed in rear. Attached metal carport on east side. Resource 1129 is contributing to the recommended NRHP-eligible East 1st Street Historic District. However, it does not possess historical or architectural significance within the historic contexts necessary for individual listing in the NRHP under Criteria A, B, or C.

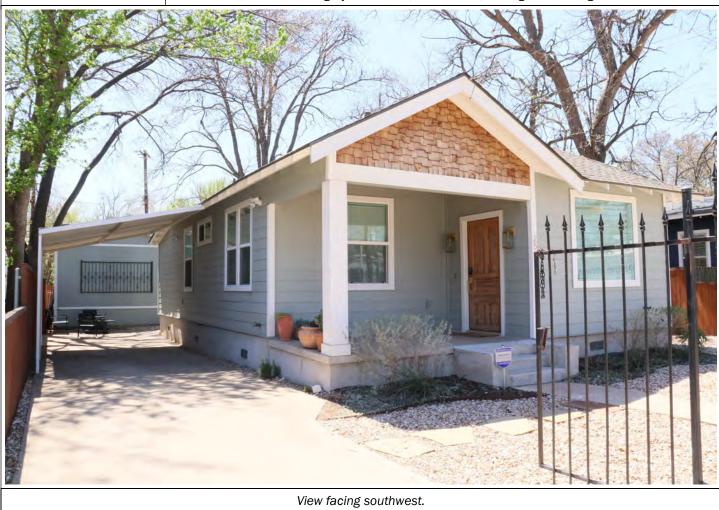
Survey Date:	March 31, 2022
Resource No.	1130
Project Location:	Austin, Travis County, Texas. I-35 from US 290 E to US 290 W/SH 71
Project Name and CSJ:	I-35 Capital Express Central Reconnaissance Survey - East Cesar Chavez Street Addendum, 0015-13-388
Address, Lat/Long:	2505 East Cesar Chavez Street, 30.254077/-97.716390
Function/Sub-function:	DOMESTIC/Single Dwelling
Construction Date:	1920
Architectural Style/Form:	No style
NRHP Eligibility:	Not individually eligible but remains a historic property as a contributing resource to the recommended NRHP-eligible East 1st Street Historic District (Criteria A and C).
Description/Comments:	One-story, rectangular-plan, clipped side-gable residence. Pier and beam foundation. Asphalt- shingle roof. Horizontal wood cladding. Half-circle awning over entry. Wood sash windows. Resource 1130 is contributing to the recommended NRHP-eligible East 1st Street Historic District. However, it does not possess historical or architectural significance within the historic contexts necessary for individual listing in the NRHP under Criteria A, B, or C.

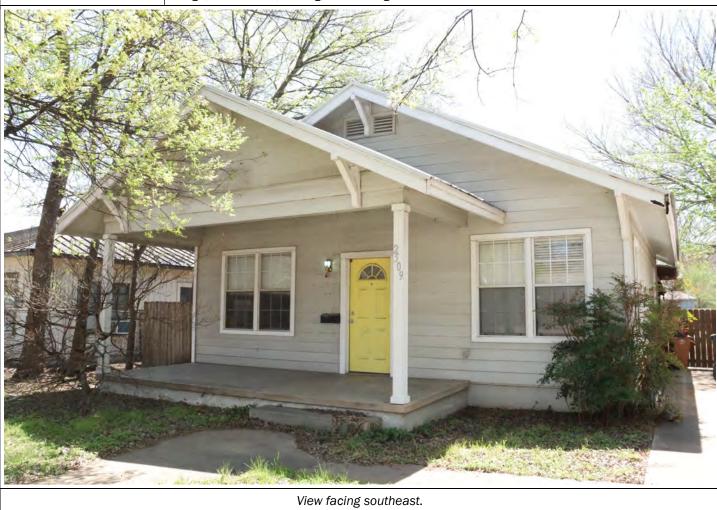
Project Location: Project Name and CSJ: Address, Lat/Long: Function/Sub-function: Construction Date: Architectural Style/Form: NRHP Eligibility: Description/Comments: Integrity Considerations:	1133 Austin, Travis County, Texas. I-35 from US 290 E to US 290 W/SH 71 I-35 Capital Express Central Reconnaissance Survey - East Cesar Chavez Street Addendum, 0015-13-388 2511 East Cesar Chavez Street, 30.253882/-97.715976 DOMESTIC/Single Dwelling 1930 Bungalow Not individually eligible but remains a historic property as a contributing resource to the recommended NRHP-eligible East 1st Street Historic District (Criteria A and C). One-story, rectangular-plan, hip-roof bungalow. Pier and beam foundation. Horizontal wood and board and batten siding. Metal roof. Partial-width, flat-roof porch with box columns. 1/1 wood and metal sash windows. Historic-age addition on rear elevation. Resource 1133 is contributing to the recommended NRHP-eligible East 1st Street Historic District. However, it does not possess historical or architectural significance within the historic contexts necessary for individual listing in the NRHP under Criteria A, B, or C. Alterations include replacement windows and doors. Despite minor alterations, Resource 1133 retains all aspects of integrity.

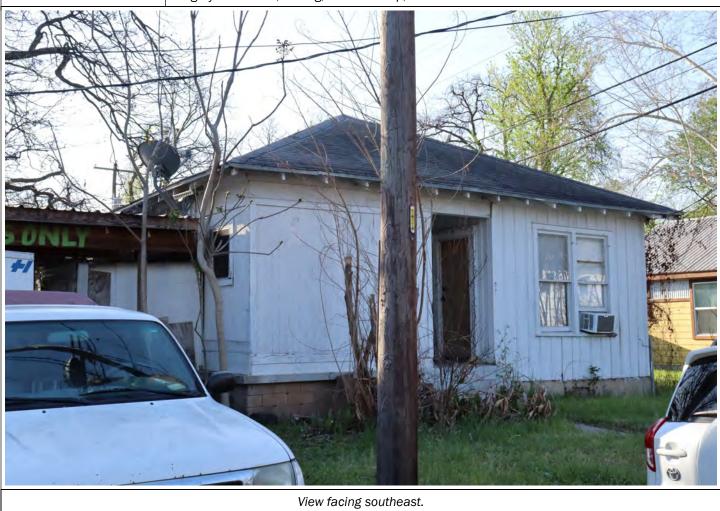
Survey Date:	April 1, 2022
Resource No.	1140
Project Location:	Austin, Travis County, Texas. I-35 from US 290 E to US 290 W/SH 71
Project Name and CSJ:	I-35 Capital Express Central Reconnaissance Survey - East Cesar Chavez Street Addendum, 0015-13-388
Address, Lat/Long:	2605 East Cesar Chavez Street, 30.253628/-97.715069
Function/Sub-function:	DOMESTIC/Single Dwelling (now COMMERCE/TRADE/Business)
Construction Date:	1938
Architectural Style/Form:	No style
NRHP Eligibility:	Noncontributing to the recommended NRHP-eligible East 1st Street Historic District (Criteria A and C); not individually eligible.
Description/Comments:	One-story, rectangular-plan, side-gable residence converted for commercial use. Pier and beam foundation. Horizontal wood and plywood siding. Asphalt-shingle roof. Full-width, flat-roof porch with wood supports and railing. Fixed frame vinyl windows. Large, shed-roof addition on rear elevation creates an asymmetrical gable. Resource 1140 is noncontributing to the recommended NRHP-eligible East 1st Street Historic District and does not possess historical or architectural significance within the historic contexts necessary for individual listing in the NRHP under Criteria A, B, or C.

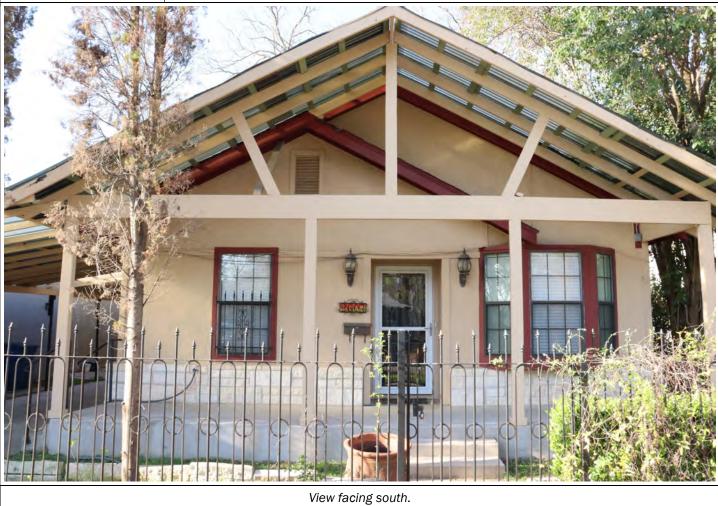
Survey Date:	April 1, 2022
Resource No.	1142A
Project Location:	Austin, Travis County, Texas. I-35 from US 290 E to US 290 W/SH 71
Project Name and CSJ:	I-35 Capital Express Central Reconnaissance Survey - East Cesar Chavez Street Addendum, 0015-13-388
Address, Lat/Long:	2609 East Cesar Chavez Street, 30.253214/-97.714737
Function/Sub-function:	DOMESTIC/Multiple Dwelling
Construction Date:	1973
Architectural Style/Form:	No style
NRHP Eligibility:	Not individually eligible but remains a historic property as a contributing resource to the recommended NRHP-eligible East 1st Street Historic District (Criteria A and C).
Description/Comments:	Two-story, L-plan, hip-roof apartment building. Concrete slab foundation. Stucco walls. Asphalt- shingle roof. Covered walkway on facade with square, stucco columns and arched openings. Exterior metal stairs access second-story walkway at each end. Metal sliding windows. Resource 1142A is contributing to the recommended NRHP-eligible East 1st Street Historic District. However, it does not possess historical or architectural significance within the historic contexts necessary for individual listing in the NRHP under Criteria A, B, or C.

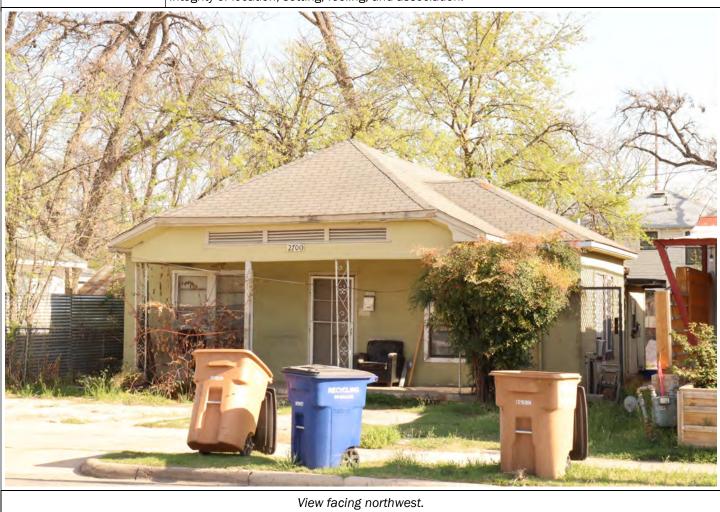
Survey Date:	April 1, 2022
Resource No.	1145B
Project Location:	Austin, Travis County, Texas. I-35 from US 290 E to US 290 W/SH 71
Project Name and CSJ:	I-35 Capital Express Central Reconnaissance Survey - East Cesar Chavez Street Addendum, 0015-13-388
Address, Lat/Long:	2700 East Cesar Chavez Street, 30.253763/-97.713939
Function/Sub-function:	DOMESTIC/Secondary Structure
Construction Date:	c.1930
Architectural Style/Form:	No style
NRHP Eligibility:	Not individually eligible but remains a historic property as a contributing resource to the recommended NRHP-eligible East 1st Street Historic District (Criteria A and C).
Description/Comments:	One-story, rectangular-plan, front-gable shed. Board and batten and plywood siding. Metal roof. No visible windows. Resource 1145B is contributing to the recommended NRHP-eligible East 1st Street Historic District. However, it does not possess historical or architectural significance within the historic contexts necessary for individual listing in the NRHP under Criteria A, B, or C.

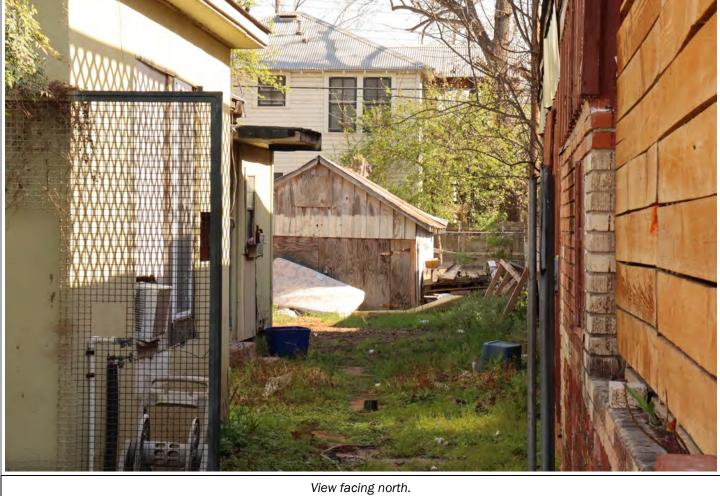
Survey Date:	April 1, 2022
Resource No.	1146
Project Location:	Austin, Travis County, Texas. I-35 from US 290 E to US 290 W/SH 71
Project Name and CSJ:	I-35 Capital Express Central Reconnaissance Survey - East Cesar Chavez Street Addendum, 0015-13-388
Address, Lat/Long:	2702 East Cesar Chavez Street, 30.253559/-97.713904
Function/Sub-function:	DOMESTIC/Single Dwelling (now COMMERCE/TRADE/Business)
Construction Date:	1930
Architectural Style/Form:	Bungalow
NRHP Eligibility:	Not eligible.
Description/Comments:	One-story, rectangular-plan, hip-roof bungalow. Board and batten siding with brick veneer on lower portions of walls. Asphalt-shingle roof. Partial-width, shed-roof patio on facade. Fixed wood-frame windows. Non-historic-age, board and batten addition on west elevation and non-historic-age, shed-roof covered patio addition on rear elevation. Resource 1146 does not possess historical or architectural significance within the historic contexts necessary for individual listing in the NRHP under Criteria A, B, or C.

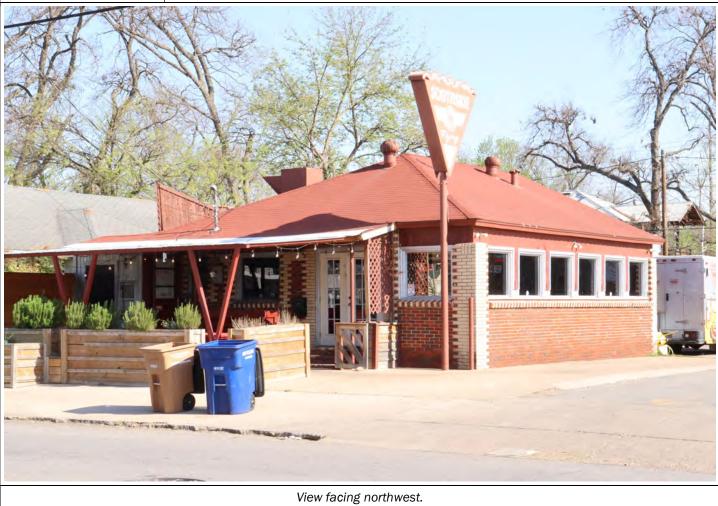
Resource No.       1147         Project Location:       Austin, Travis County, Texas. I-35 from US 290 E to US 290 W/SH 71         Project Location:       L35 Capital Express Central Reconnaissance Survey - East Cesar Chavez Street Addendum, 0015-13-388         Address, Lat/Long:       2701 East Cesar Chavez Street, 30.253222/97.714075         Function/Sub-function:       DOMESTIC/Multiple Dwelling (now COMMERCE/TRADE/Business)         Construction Date:       1930         Architectural Style/Form:       Bungalow         NRHP Eligibility:       Not individually eligible but remains a historic property as a contributing resource to the recommended NRHP-eligible East 1st Storet Historic District (Criteria A and C).         Description/Comments:       One-story, recreangular-plan, hip-roof, bungalow duplex converted for commercial use. Pier and beam foundation. Brick massonry walis, horizontal wood siding in gable. Asphalt-shingle roof.         Partial-width, gable-roof ports and raining. Freed metal and 1/1 wood sash windows. Resource 11.47 is contributing to the recommended NRHP-eligible East 1st Street Historic contexts necessary for individual listing in the NRHP under Criteria A, B, or C.         Integrity Considerations:       Alterations include replacement windows and doors, and altered fenestration. One of two front. doors has been infiled. Due alterations, Resource 1147 has lost integrity of design and feeling but retains integrity of setting, location, materials, workmanship, and association.         Integrity Considerations:       Alterations include replacement windows and doors, and altered f	Survey Date:	April 1, 2022

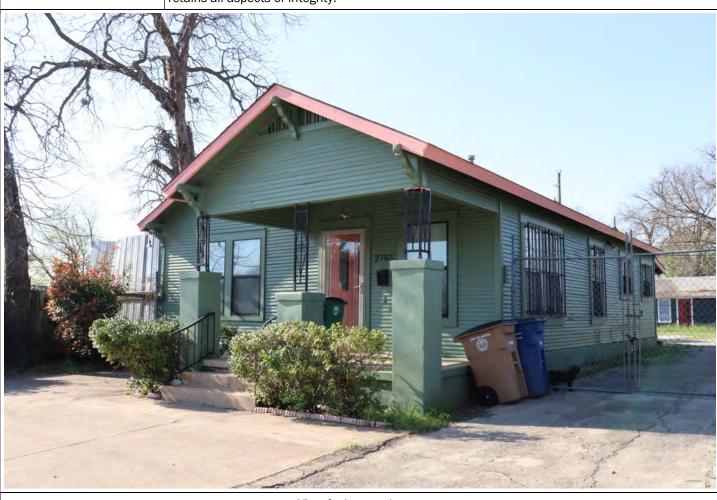
Survey Date:	April 1, 2022
Resource No.	1148
Project Location:	Austin, Travis County, Texas. I-35 from US 290 E to US 290 W/SH 71
Project Name and CSJ:	I-35 Capital Express Central Reconnaissance Survey - East Cesar Chavez Street Addendum, 0015-13-388
Address, Lat/Long:	2703 East Cesar Chavez Street, 30.253191/-97.713937
Function/Sub-function:	DOMESTIC/Single Dwelling
Construction Date:	1930
Architectural Style/Form:	Bungalow
NRHP Eligibility:	Not individually eligible but remains a historic property as a contributing resource to the recommended NRHP-eligible East 1st Street Historic District (Criteria A and C).
Description/Comments:	One-story, rectangular-plan, front-gable bungalow. Pier and beam foundation. Horizontal wood siding. Asphalt-shingle roof. Partial width, gable-roof porch with stucco piers and iron supports. Vinyl and metal sash windows with added iron security bars. Resource 1148 is contributing to the recommended NRHP-eligible East 1st Street Historic District. However, it does not possess historical or architectural significance within the historic contexts necessary for individual listing in the NRHP under Criteria A, B, or C.

Integrity Considerations:	Alterations include replacement windows and doors. Despite minor alterations, Resource 1148 retains all aspects of integrity.

View facing southeast.

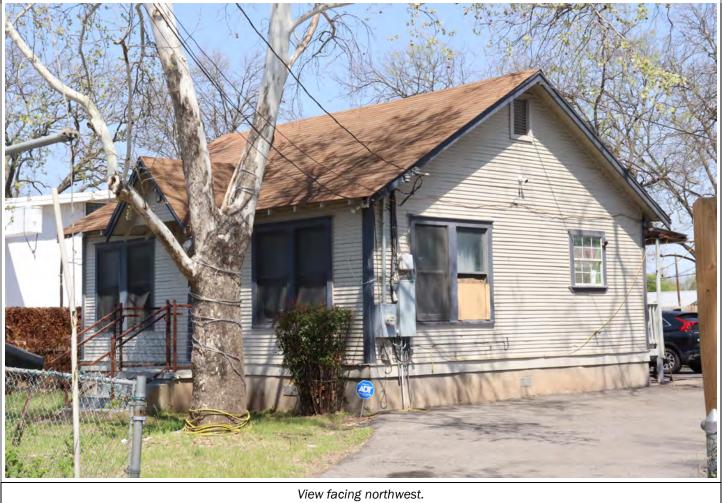
Survey Date:	April 1, 2022
Resource No.	1153A
Project Location:	Austin, Travis County, Texas. I-35 from US 290 E to US 290 W/SH 71
Project Name and CSJ:	I-35 Capital Express Central Reconnaissance Survey - East Cesar Chavez Street Addendum, 0015-13-388
Address, Lat/Long:	2922 East Cesar Chavez Street, 30.252980/-97.710762
Function/Sub-function:	DOMESTIC/Single Dwelling (now COMMERCE/TRADE/Business)
Construction Date:	1907
Architectural Style/Form:	Folk Victorian
NRHP Eligibility:	Not eligible.
Description/Comments:	One-story, L-plan, cross-gable, Folk Victorian residence converted for use as a bar. Pier and beam foundation. Horizontal wood siding. Brick chimneys. Asphalt-shingle roof. Partial-width, shed-roof porch with simple wood post supports. See HRSR text for evaluation. Resource 1153A does not possess historical or architectural significance within the historic contexts necessary for individual listing in the NRHP under Criteria A, B, or C.

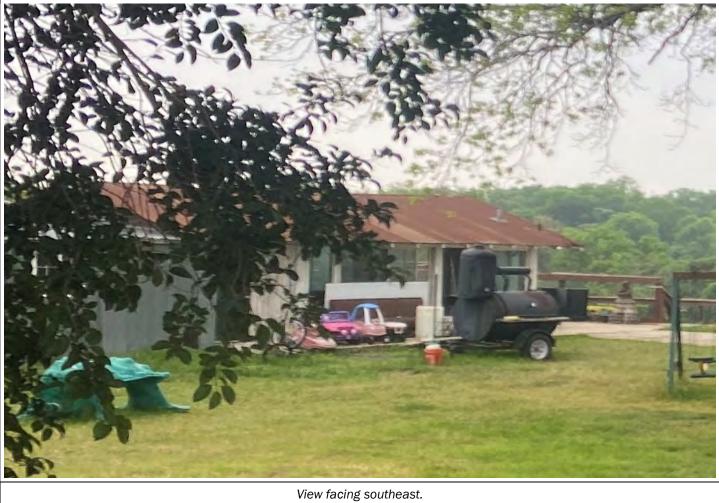
Survey Date:	June 16, 2022
Resource No.	1157
Project Location:	Austin, Travis County, Texas. I-35 from US 290 E to US 290 W/SH 71
Project Name and CSJ:	I-35 Capital Express Central Reconnaissance Survey - East Cesar Chavez Street Addendum, 0015-13-388
Address, Lat/Long:	3201 East Cesar Chavez Street, 30.251434/-97.708504
Function/Sub-function:	DOMESTIC/Multiple Dwelling (now COMMERCE/TRADE/Restaurant)
Construction Date:	1944
Architectural Style/Form:	No style
NRHP Eligibility:	Not eligible.
Description/Comments:	One-story, L-plan, side-gable, small apartment building converted to restaurant. Stucco exterior walls. Metal roof. Window openings appear to have been modified; replacement fixed metal windows. Industrial equipment mounted on roof. Flat-roof covered patio connects this building to adjacent building. Resource 1157 does not possess historical or architectural significance within the historic contexts necessary for individual listing in the NRHP under Criteria A, B, or C.

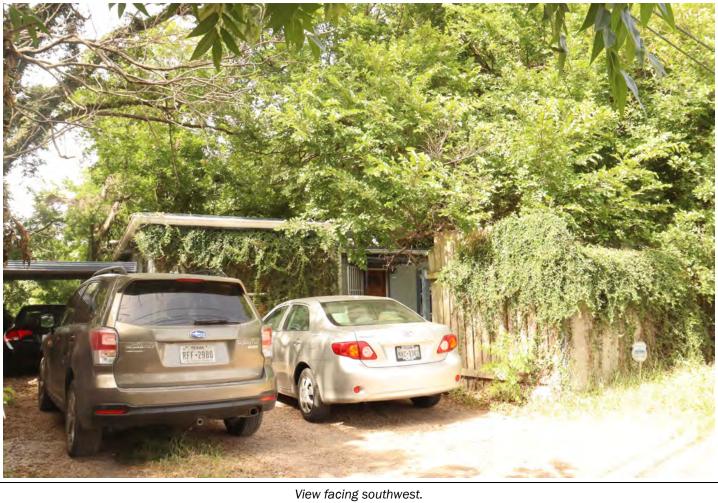
Survey Date:	June 16, 2022
Resource No.	1160
Project Location:	Austin, Travis County, Texas. I-35 from US 290 E to US 290 W/SH 71
Project Name and CSJ:	I-35 Capital Express Central Reconnaissance Survey - East Cesar Chavez Street Addendum, 0015-13-388
Address, Lat/Long:	3211 East Cesar Chavez Street, 30.251529/-97.707746
Function/Sub-function:	DOMESTIC/Single Dwelling
Construction Date:	1957
Architectural Style/Form:	No style
NRHP Eligibility:	Not eligible.
Description/Comments:	One-story, rectangular-plan, side-gable residence. Brick exterior walls. Asphalt-shingle roof. Inset porch at center of facade with wrought-iron supports. Two-car integrated garage with panel doors at east end. View largely obscured by privacy fence and dense vegetation. Resource 1160 does not possess historical or architectural significance within the historic contexts necessary for individual listing in the NRHP under Criteria A, B, or C.

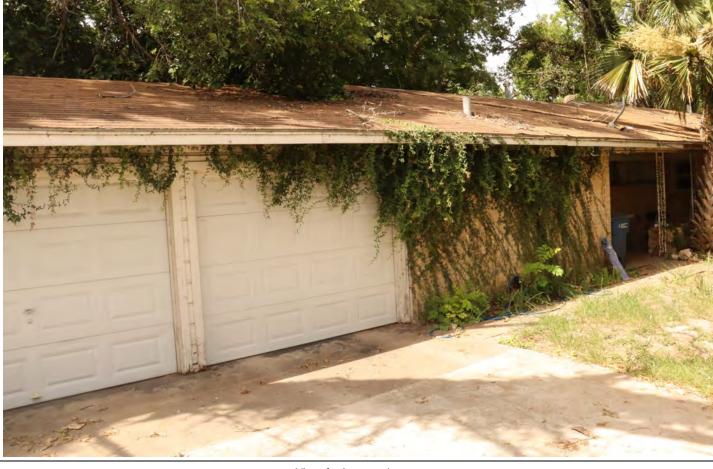
Integrity Considerations:	There are no visible alterations. Resource 1160 retains all aspects of integrity.

View facing southwest.

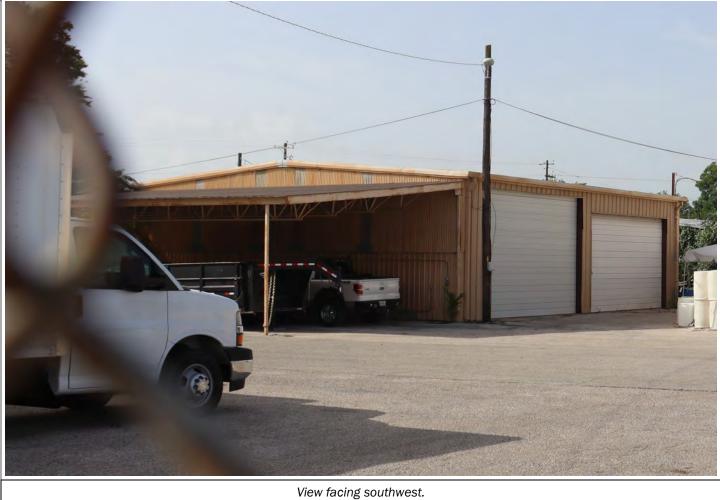
Resource No.	June 16, 2022
	1165
Project Location:	Austin, Travis County, Texas. I-35 from US 290 E to US 290 W/SH 71
Project Name and CSJ:	I-35 Capital Express Central Reconnaissance Survey - East Cesar Chavez Street Addendum, 0015-13-388
Address, Lat/Long:	102 Springdale Road, 30.252237/-97.704363
Function/Sub-function:	COMMERCE/TRADE/Business (now VACANT/Not in Use)
Construction Date:	1947; 1961
Architectural Style/Form:	No style
NRHP Eligibility:	Not eligible.
Description/Comments:	One-story, irregular-plan, flat-roof commercial building. Concrete slab foundation. Concrete-block, stucco, corrugated metal, and plywood siding. Metal roof. Main building is concrete block with stucco. Several historic-age additions on west and north elevations. Attached shed-roof carport on rear elevation. Resource 1165 does not possess historical or architectural significance within the historic contexts necessary for individual listing in the NRHP under Criteria A, B, or C.

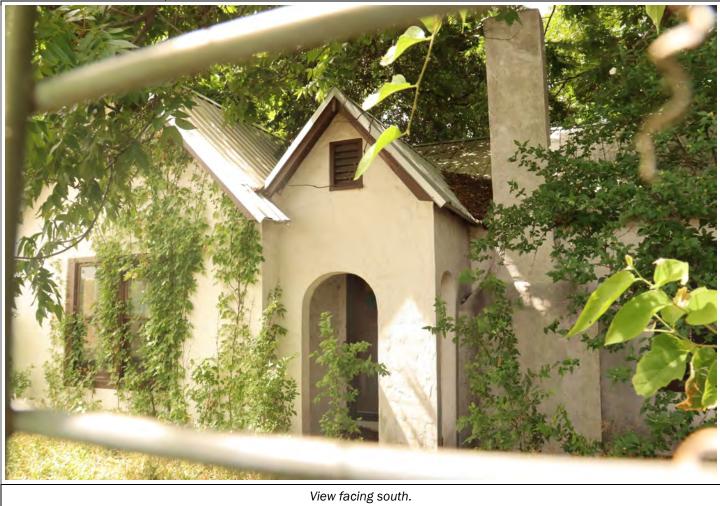
Survey Date:	June 16, 2022				
Resource No.	1167				
Project Location:	Austin, Travis County, Texas. I-35 from US 290 E to US 290 W/SH 71				
Project Name and CSJ:	I-35 Capital Express Central Reconnaissance Survey - East Cesar Chavez Street Addendum, 0015-13-388				
Address, Lat/Long:	4601 East Cesar Chavez Street, 30.251578/-97.704179				
Function/Sub-function:	DOMESTIC/Single Dwelling				
Construction Date:	1948				
Architectural Style/Form:	Minimal Traditional				
NRHP Eligibility:	Not eligible.				
Description/Comments: One-story, rectangular-plan, front-gable Minimal Traditional residence. Pier and bea Fiber cement and vinyl siding. Asphalt-shingle roof. 1/1 vinyl sash windows. Gable-risingle wooden supports. Building is constructed on the edge of a steep hill, rear of on metal posts while front sits at grade. Resource 1167 does not possess historica architectural significance within the historic contexts necessary for individual listing under Criteria A, B, or C.
