Appendix B: Tabular Inventory of Surveyed Properties

H Historical Studies Report, Texas Department of Transportation, Environmental Affairs Division

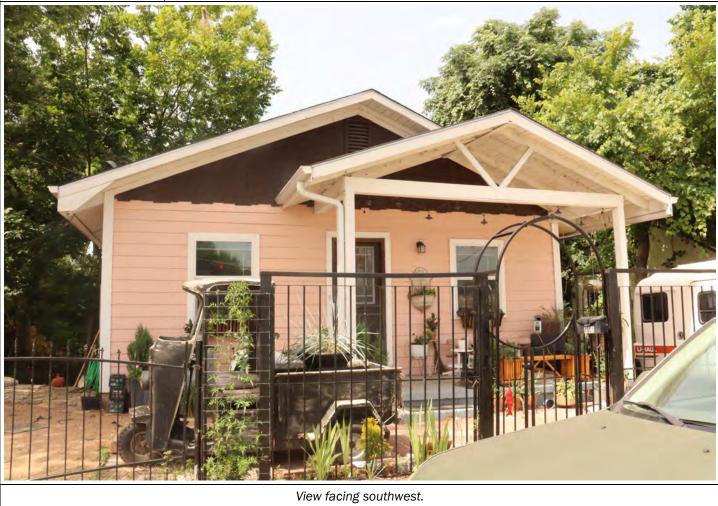
Survey Date:	June 16, 2022				
Resource No.	1167				
Project Location:	Austin, Travis County, Texas. I-35 from US 290 E to US 290 W/SH 71				
Project Name and CSJ:	I-35 Capital Express Central Reconnaissance Survey - East Cesar Chavez Street Addendum, 0015-13-388				
Address, Lat/Long:	4601 East Cesar Chavez Street, 30.251578/-97.704179				
Function/Sub-function:	DOMESTIC/Single Dwelling				
Construction Date:	1948				
Architectural Style/Form:	Minimal Traditional				
NRHP Eligibility:	Not eligible.				
Description/Comments: One-story, rectangular-plan, front-gable Minimal Traditional residence. Pier and bea Fiber cement and vinyl siding. Asphalt-shingle roof. 1/1 vinyl sash windows. Gable-risingle wooden supports. Building is constructed on the edge of a steep hill, rear of on metal posts while front sits at grade. Resource 1167 does not possess historica architectural significance within the historic contexts necessary for individual listing under Criteria A, B, or C.

Integrity Considerations: Alterations include replacement windows, doors, and siding. Due to alterations, Resource has lost integrity of materials, workmanship, and feeling but retains integrity of location, setting, and association.

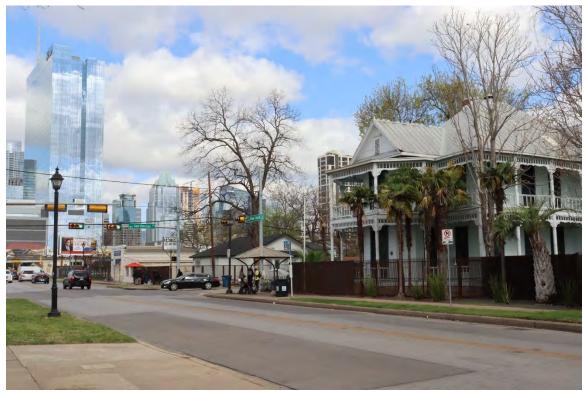
1000 block, looking northwest toward San Marcos Street. Resource 1001 at right.

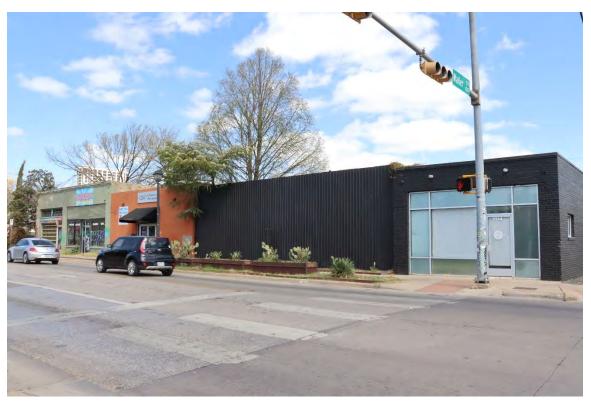
1100 block, view looking northwest. Resources 1007-1009 (left to right).

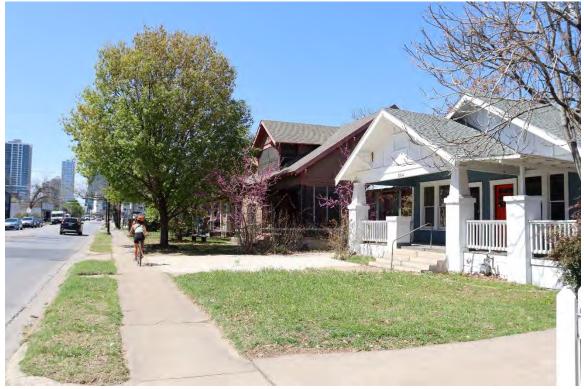
1300 block, view facing west. Resources 1022 (right) and 1021 (left) visible.

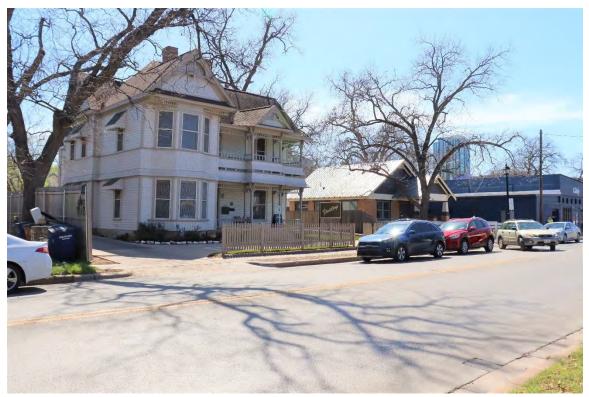
1300 block, view facing southwest. Resources 1026, 1019, and 1018 (left-right) visible.

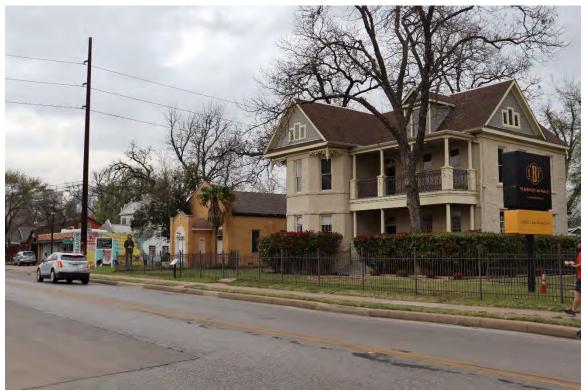
1400 block, view looking northwest. Resource 1032 visible at right.

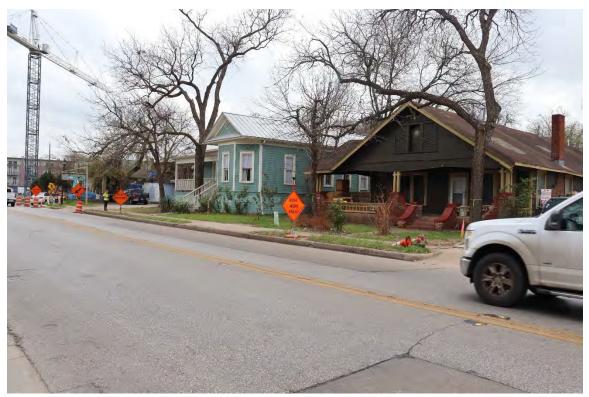
1400 block, view facing southeast. Resource 1037 (right) and 1038 (left) visible.

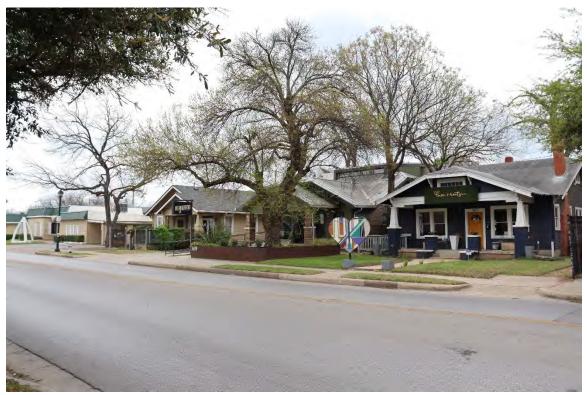
1600 block, view facing southeast. Resources 1043-1046 (right to left) visible.

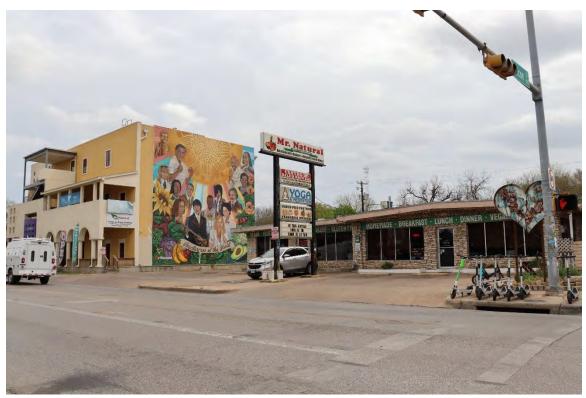
1900 block, view facing southeast. Resource 1061 at right.

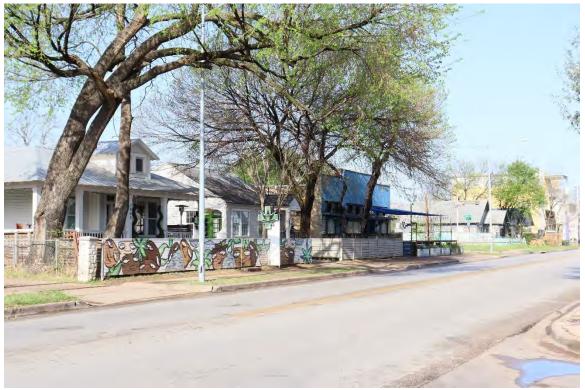
2000 block, view facing southwest. Resources 1070-1072 (right to left) visible.

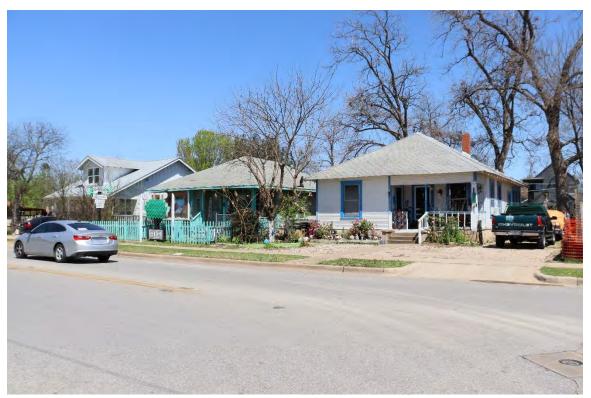
2000 block, view facing northwest. Resources 1076-1078 (left to right) visible.

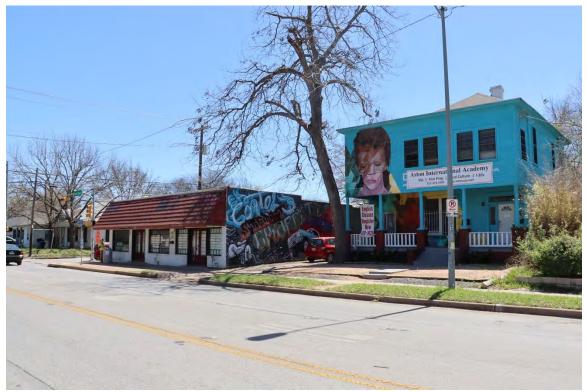
2100 block, view facing southeast. Resources 1086 (left) and 1085 (right) visible.

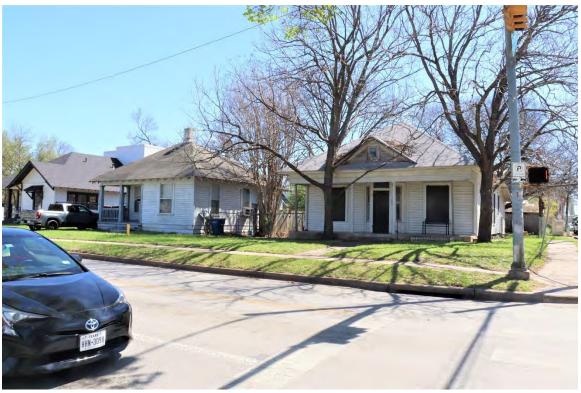
2200 block, view facing southeast. Resources 1098-1100 (right to left) visible.

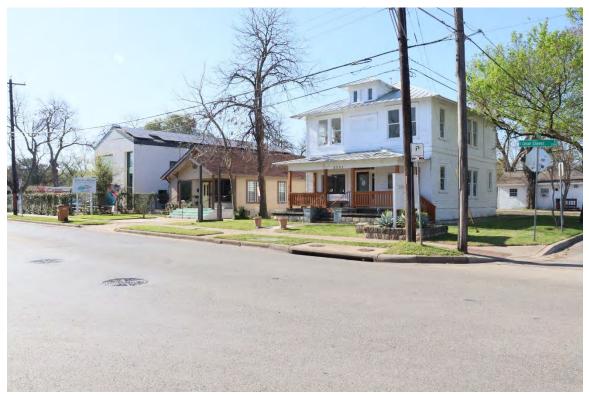
2300 block, view facing southeast. Resources 1110 (right) and 1111 (left) visible.

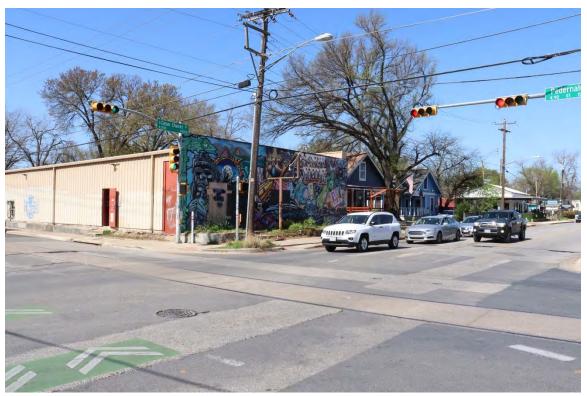
2400 block, view facing southwest. Resource 1120 visible at center.
